NORTH COUNTRY ARCHITECT  
P.O. BOX 609  
FRANCONIA, NH 03580  
[info@northcountryarchitect.com](mailto:info@northcountryarchitect.com)

## HISTORIC BUILDING ASSESSMENT FOR THE

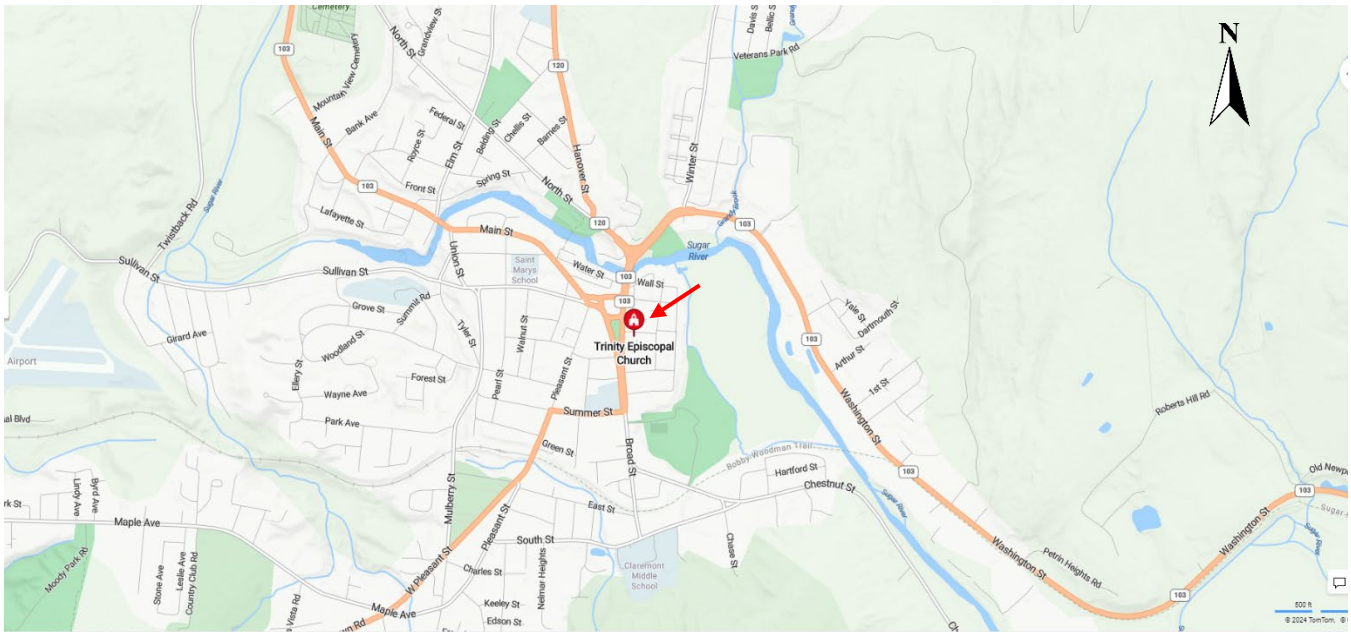
Figure 1: Location of Trinity Episcopal Church in downtown Claremont, NH

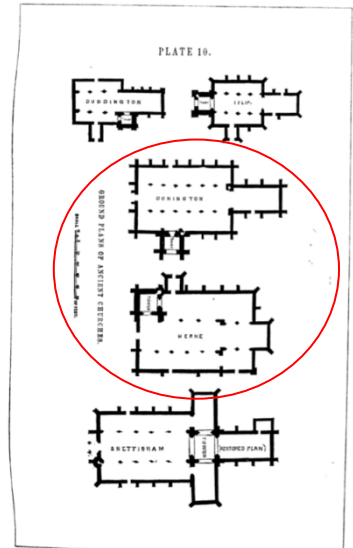
Frank Wills’ design for The House of Prayer in Newark, New Jersey is similar in form to that of Trinity Church Claremont, but with the tower placed at the east end of the church off the nave as opposed to the west at the end of the sanctuary. Wills explained that the tower placement in Newark was due to the “peculiarity of the site” and in order to render the Tower as conspicuous as possible. The House of Prayer was constructed of stone, with open roof of pine, for a sum of about \$13,000.<sup>16</sup>

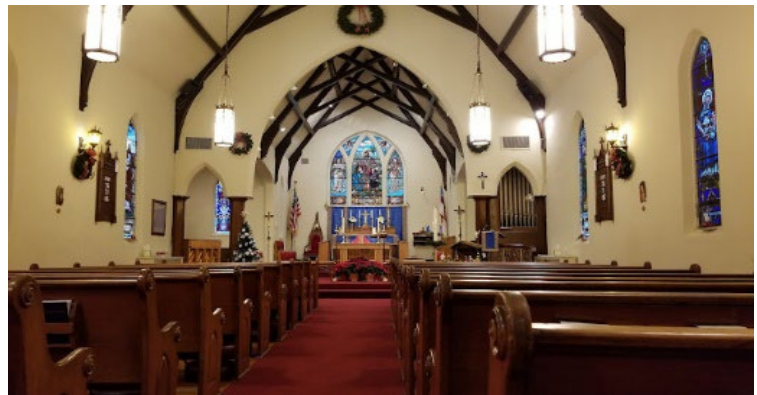
Figure 12: St. Peter’s Episcopal Church in Spotswood, NJ

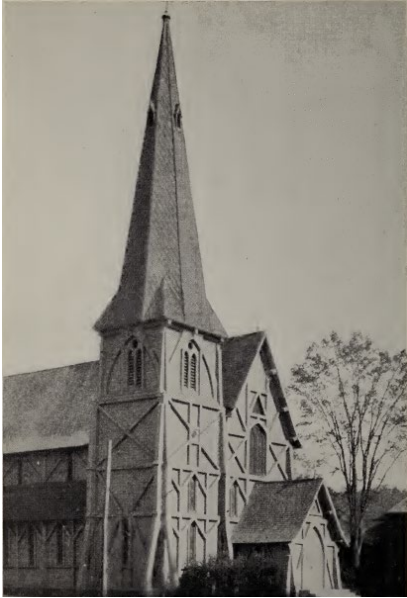
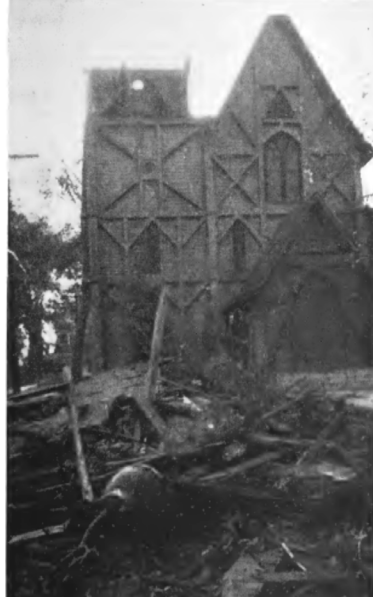
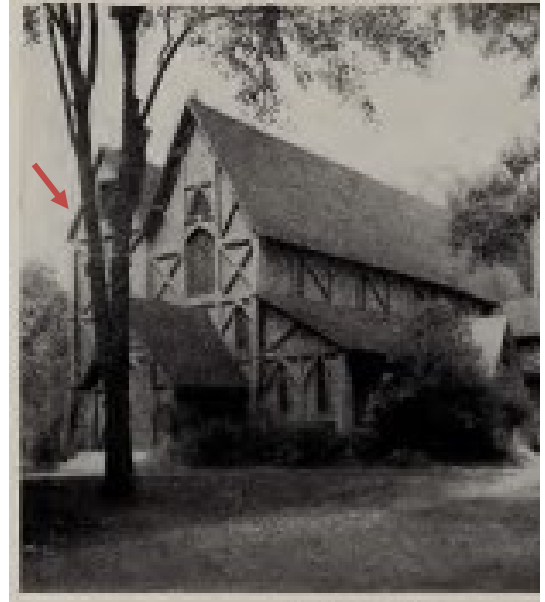
Figure 17: Trinity Church before 1938

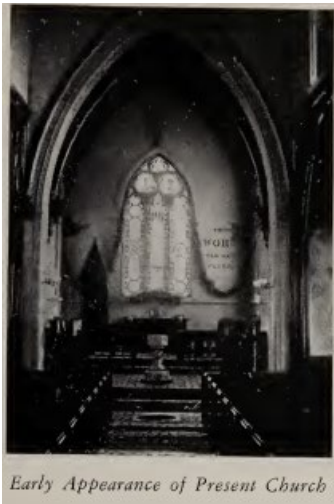
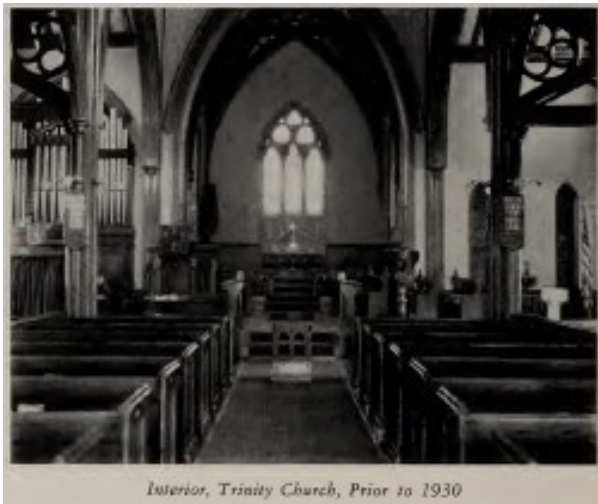
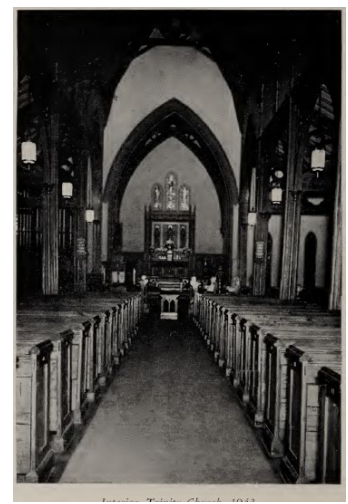
Early Appearance of Present Church

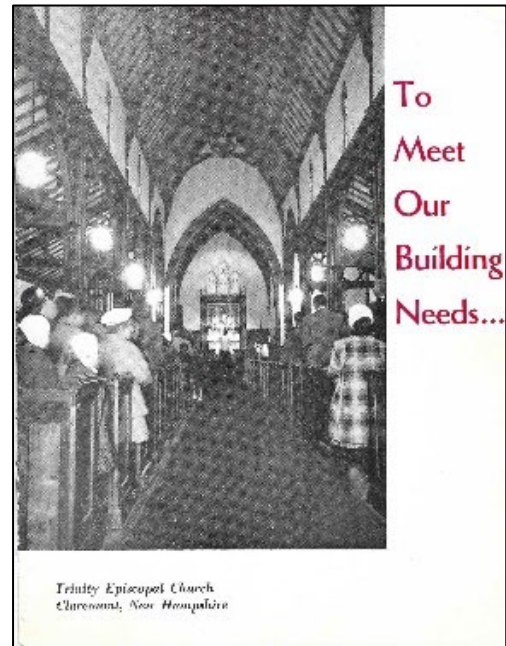
Figure 23: 1959 Booklet to the Congregation

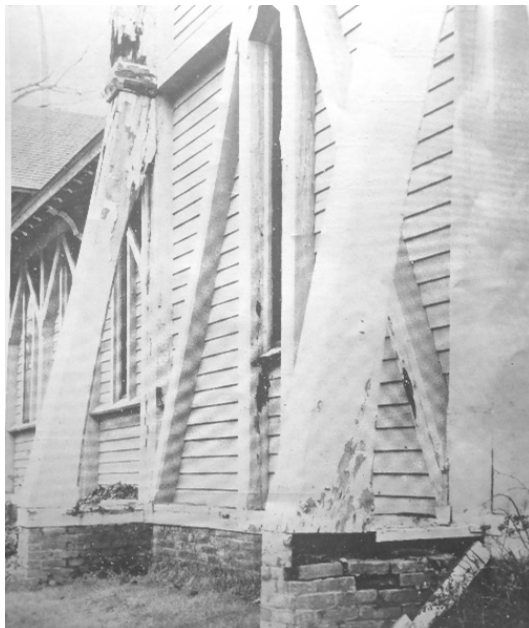
Figure 24: Deterioration at former tower buttresses, 1959

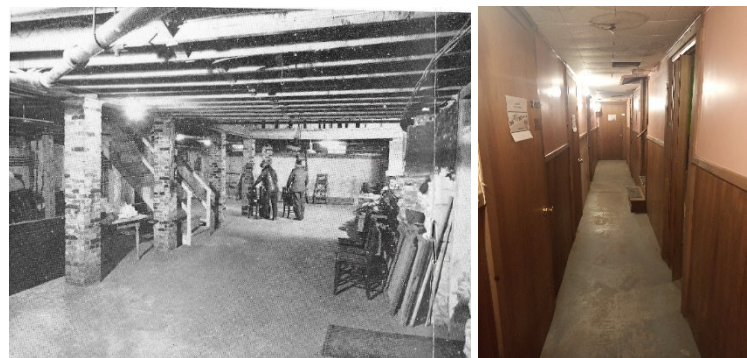
Figures 25: Basement before and after, 1959 and 2023

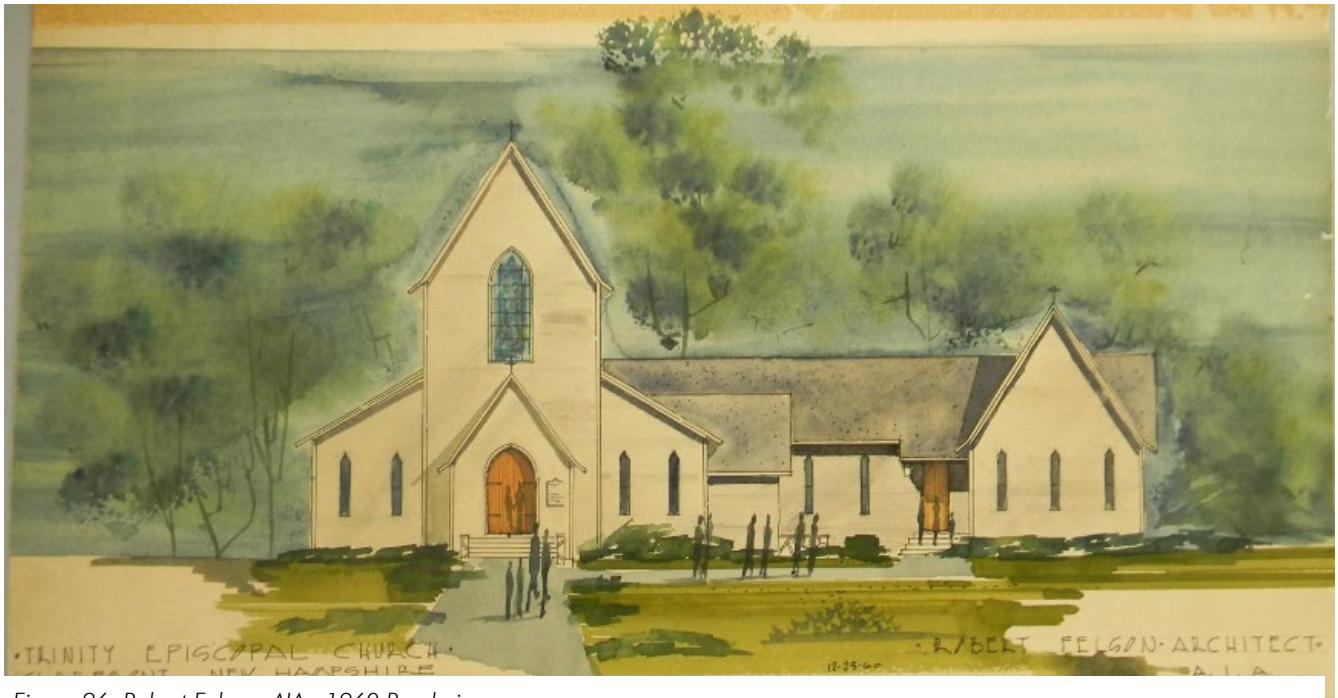
Figure 26: Robert Felson, AIA - 1960 Rendering

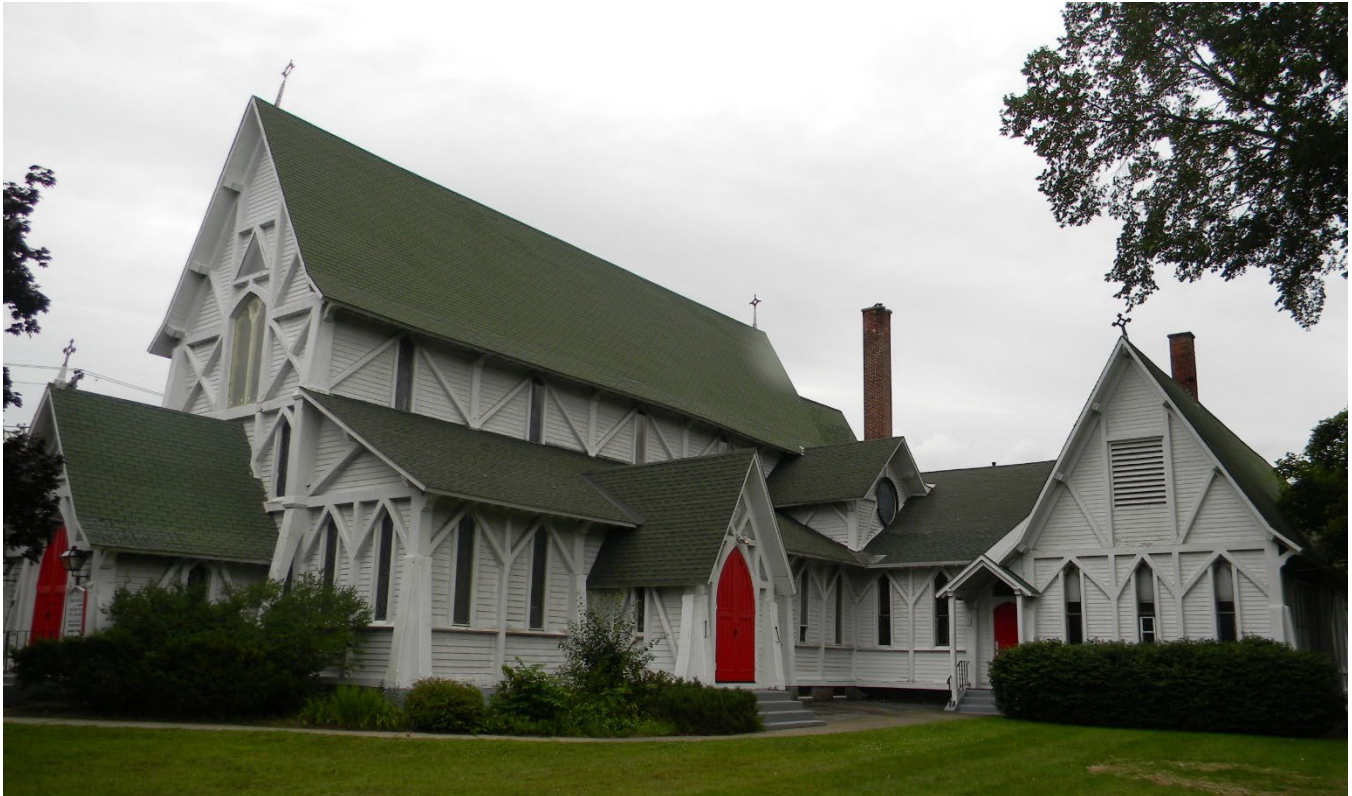
*View of West facade*

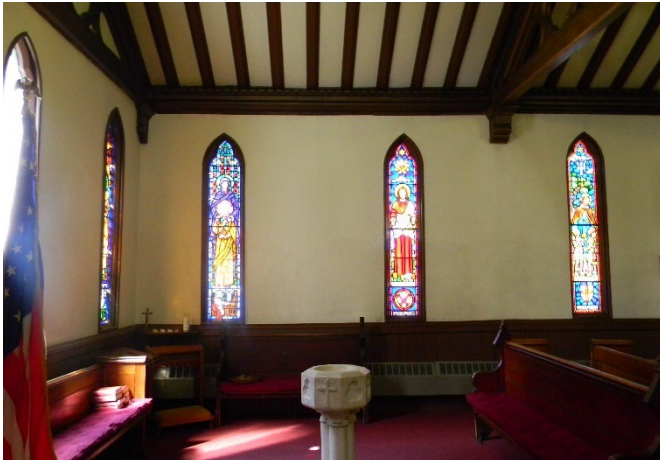
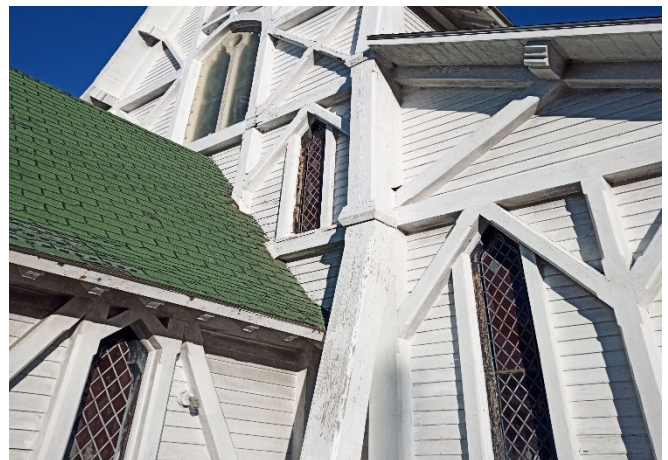
*Sanctuary (1853) interior and exterior, with Trefoil pointed arch window*

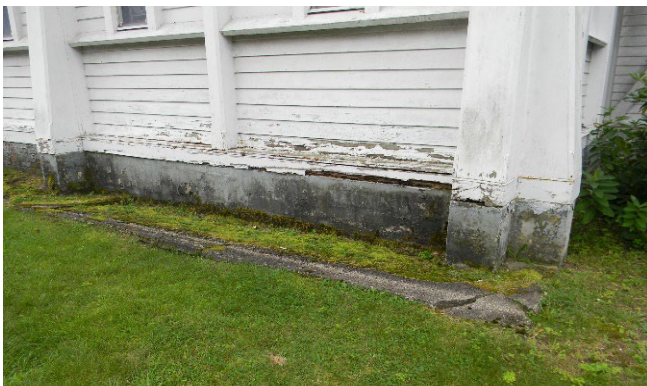
*Deteriorated foundation at west façade*

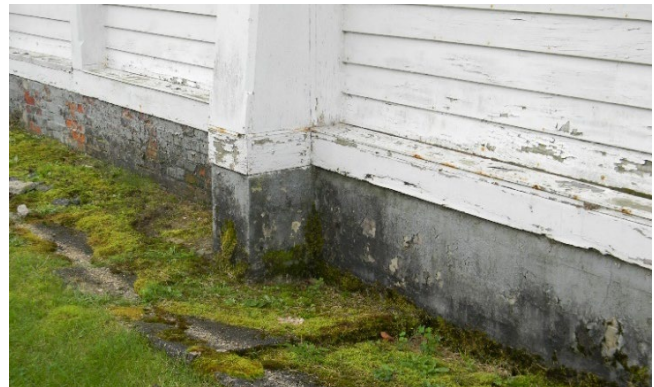
*Deteriorated foundation at west façade*

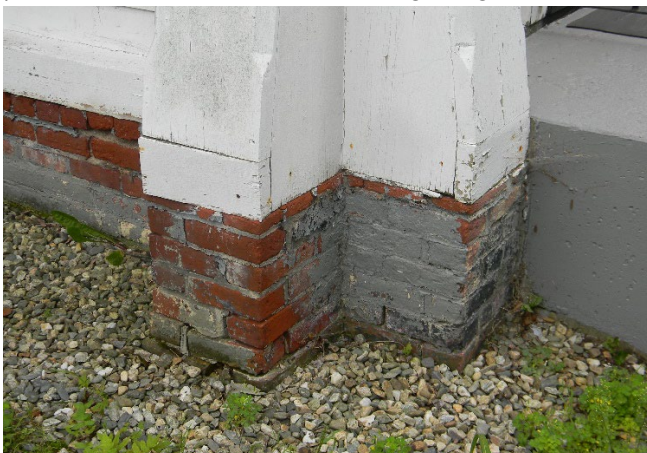
*Deterioration at buttress bases, west facade*

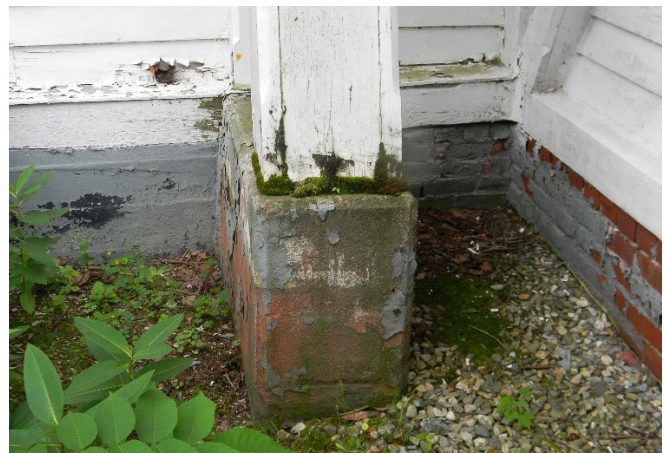
*Deterioration at buttress bases, west facade*

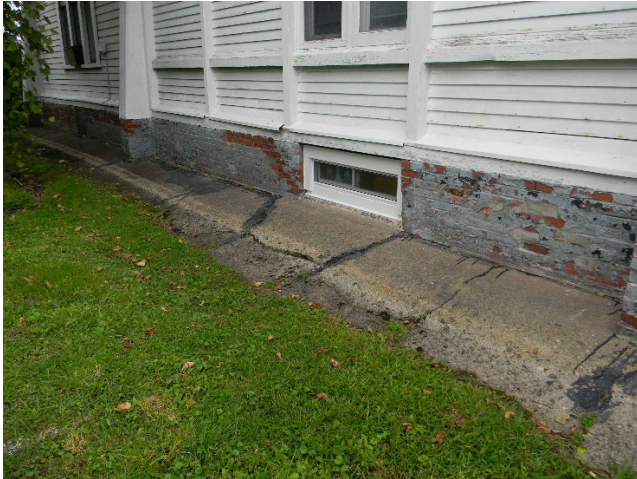
*Deterioration at buttress bases, west façade*

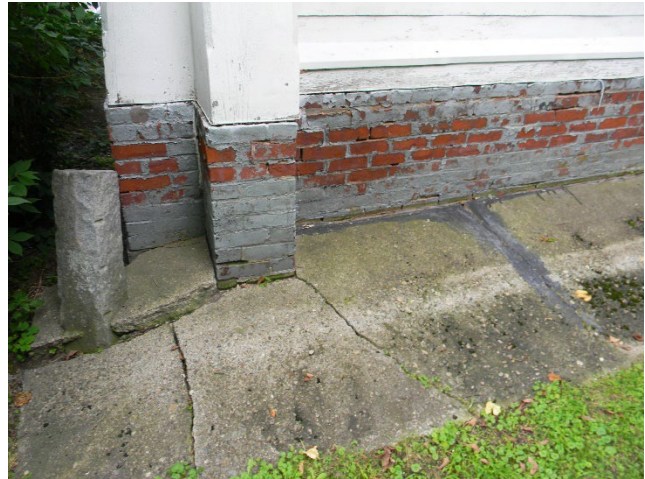
*Deterioration at buttress bases, west façade*

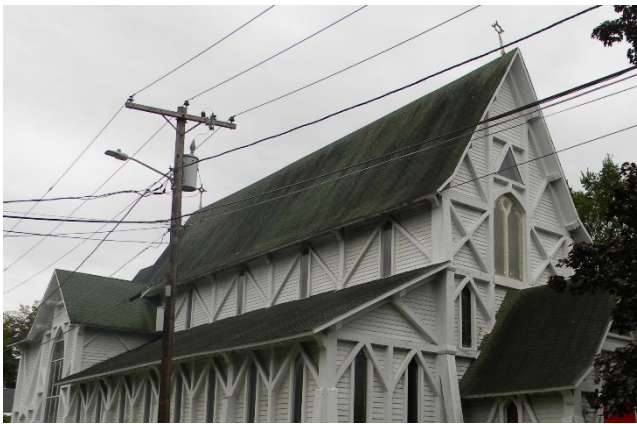
*Black-staining, deterioration at north roof planes*

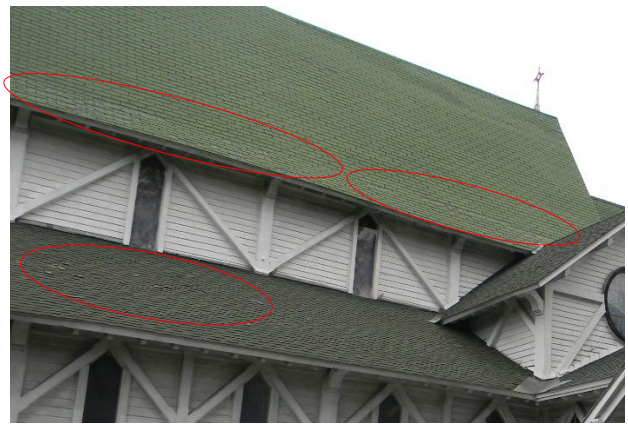
*Deteriorated shingles at south roof planes*

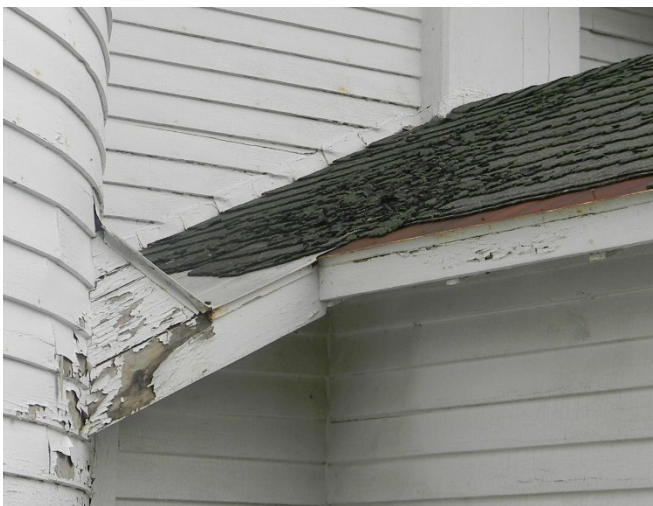
*Deteriorated shingles at rear addition*

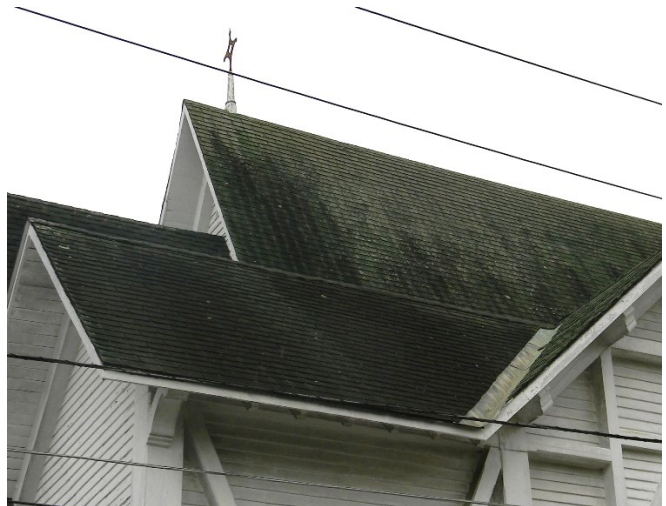
*Black staining at north roof planes*

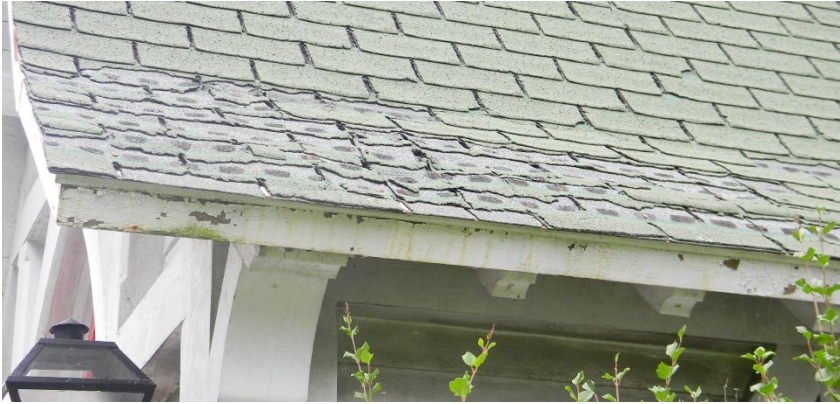
*Deterioration, loss of granules at kicked eave*

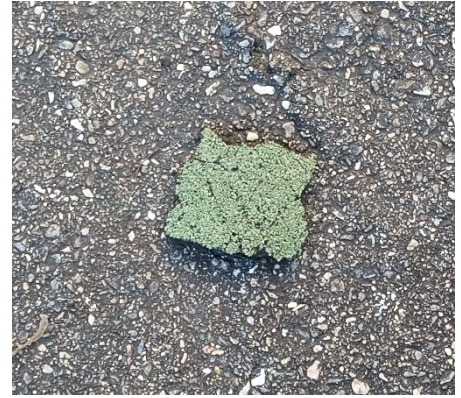
*Shingle debris throughout lawns*

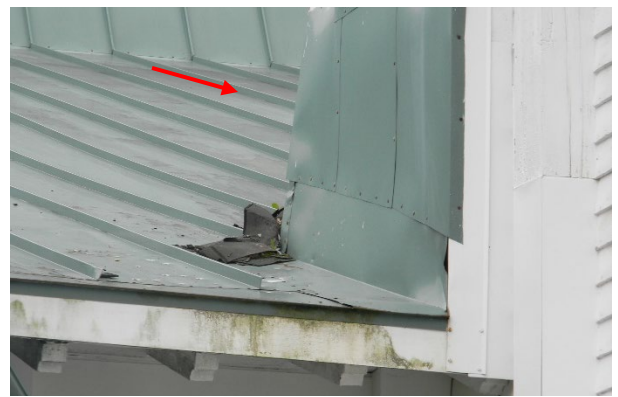
*Dislocated shingles collecting at valley; Sheet metal improperly fastened and not sealed*

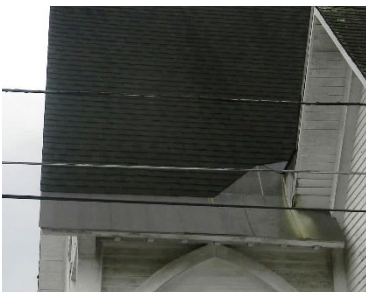
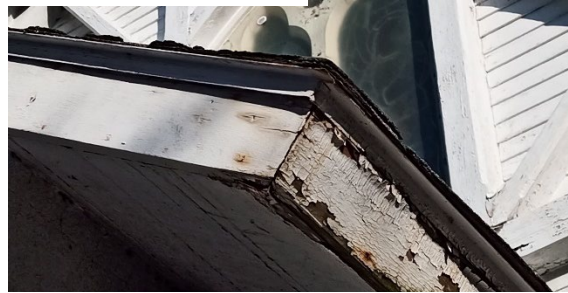
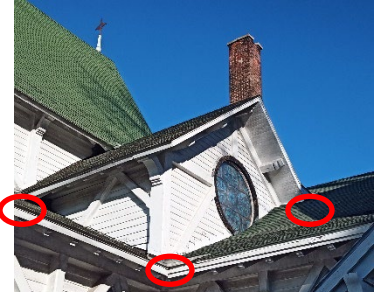
*Sheet metal apron at awkward juncture; Roof wood rake & eave trim beneath shingle loss; Awkward drainage at south transept addition.*

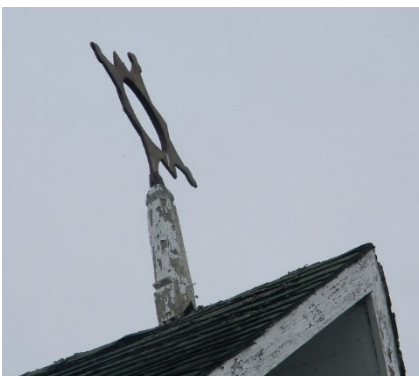
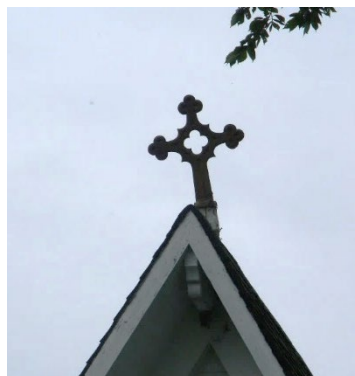
*Crosses are out-of-plane with deteriorated wood bases.*

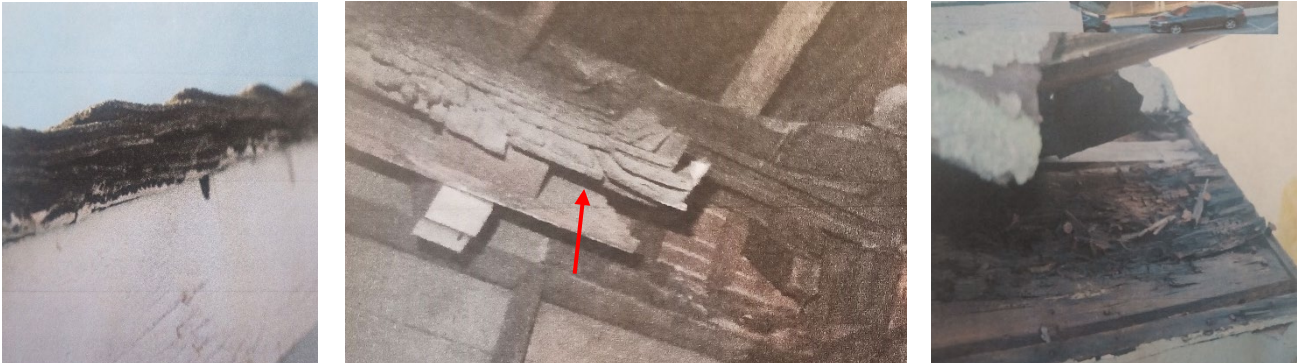
*Photographs from 2016 inspection show 3 existing layers of asphalt shingles; Wood shakes or shingles, exhibiting cupping, preserved within attic; Severe deterioration at wood eave trim.*

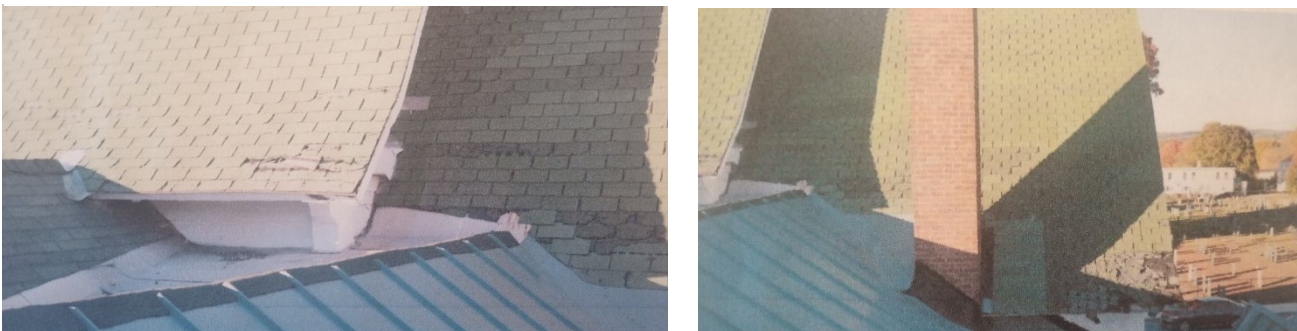
*Photographs from 2016 inspection show complicated roof junctures and difficult drainage areas where Parish hall roof meets that of Sanctuary*

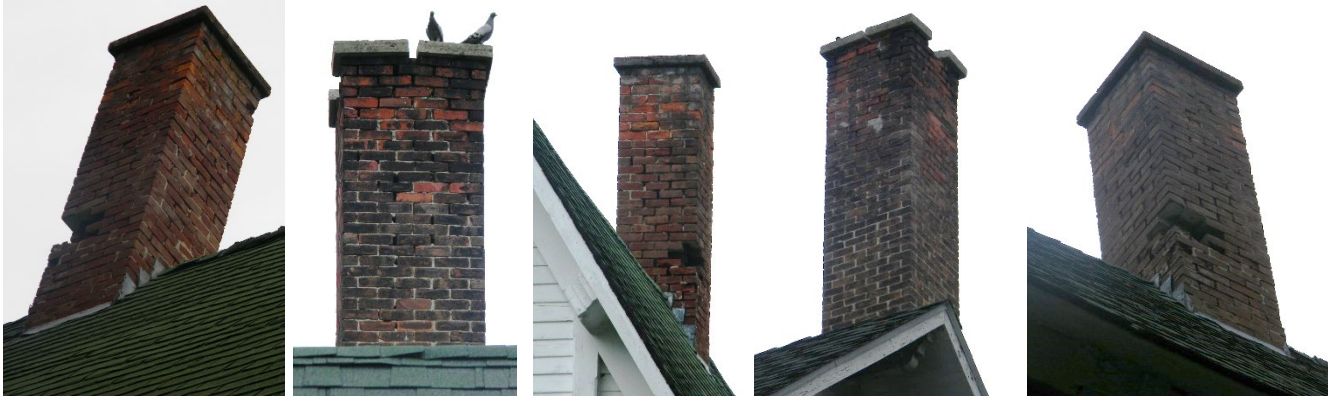
The brick perimeter walls are in poor condition. Replace all spalled/missing bricks in kind. See Foundation section for recommendations.

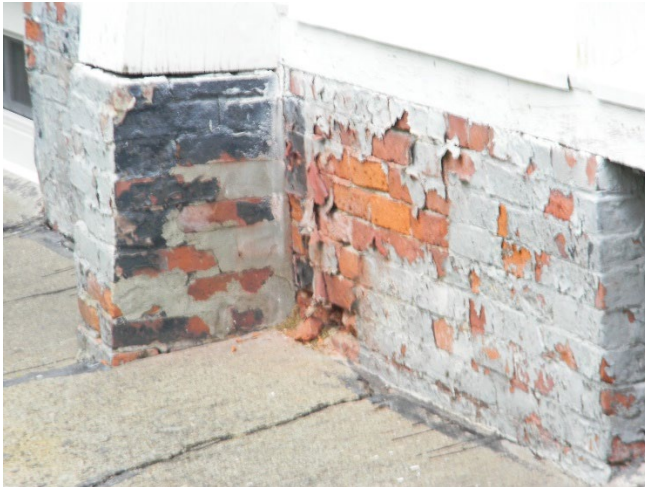
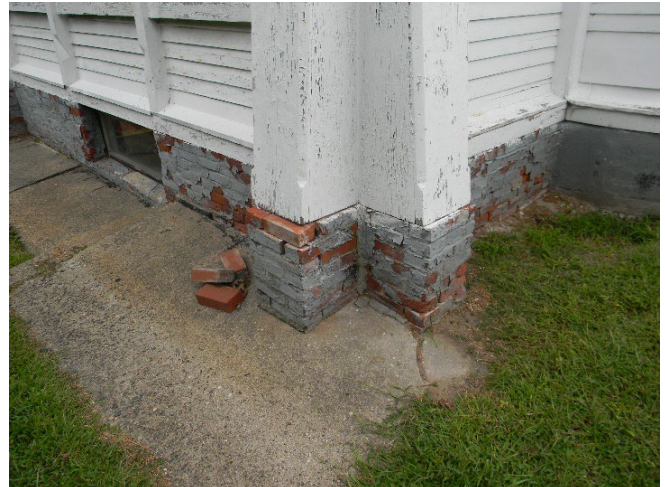
The wood siding has isolated areas of severe deterioration – rot and disintegration, staining, biological growth, paint loss.

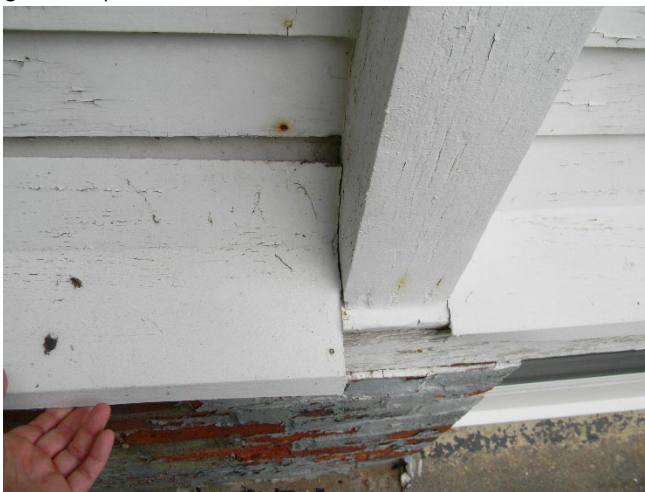
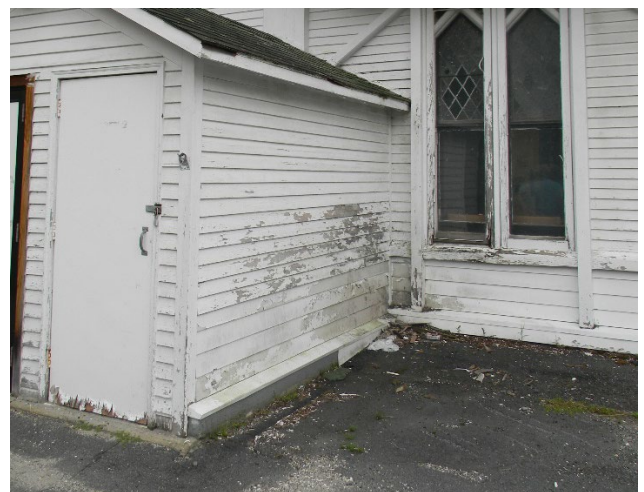
**PART III. – EXISTING CONDITIONS ASSESSMENT**

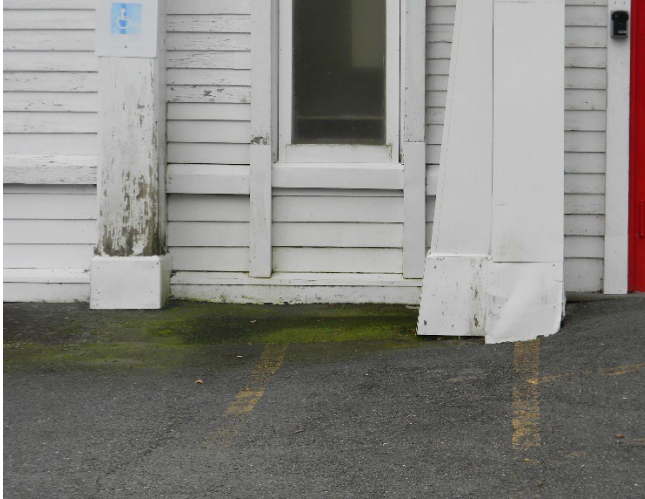
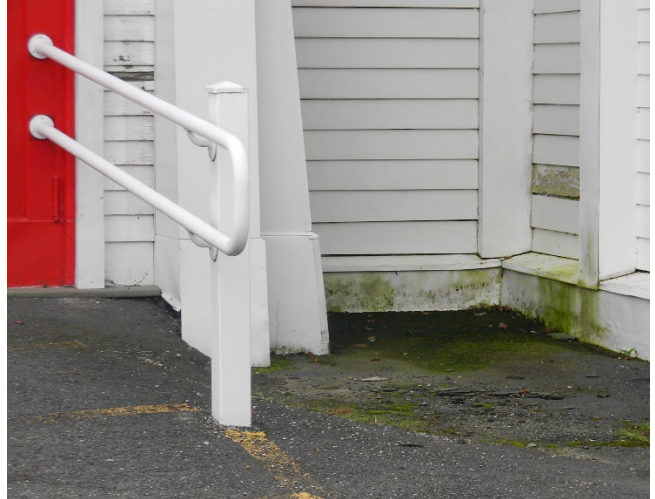
Deteriorated wood cladding. Deteriorated cladding around north entry has been clad with vinyl siding. Extensive biological growth is observed at areas of negative drainage and ponding.

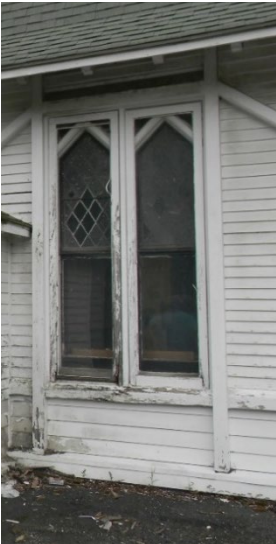
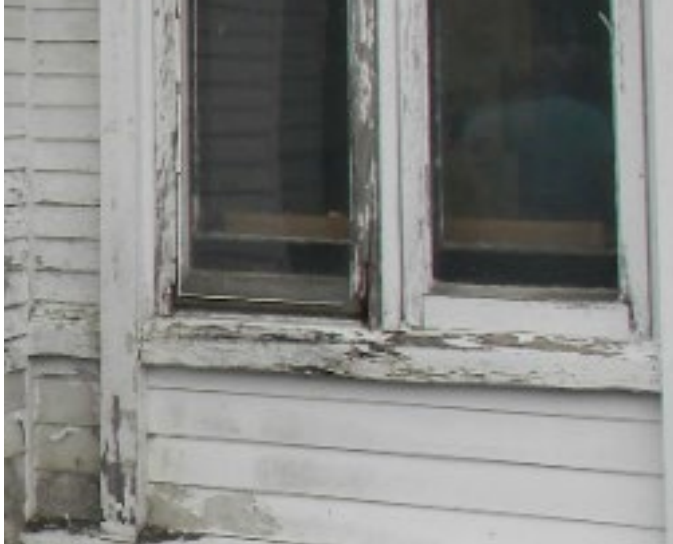
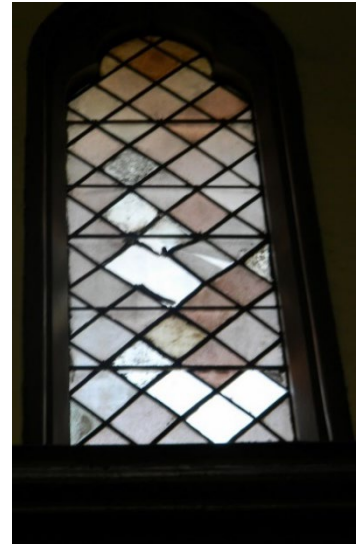
Window trim and windows exhibit varying degrees of deterioration throughout – rotted wood, loss of paint, cracked or missing panes. Deterioration is more severe at the Chapel and Parish windows.

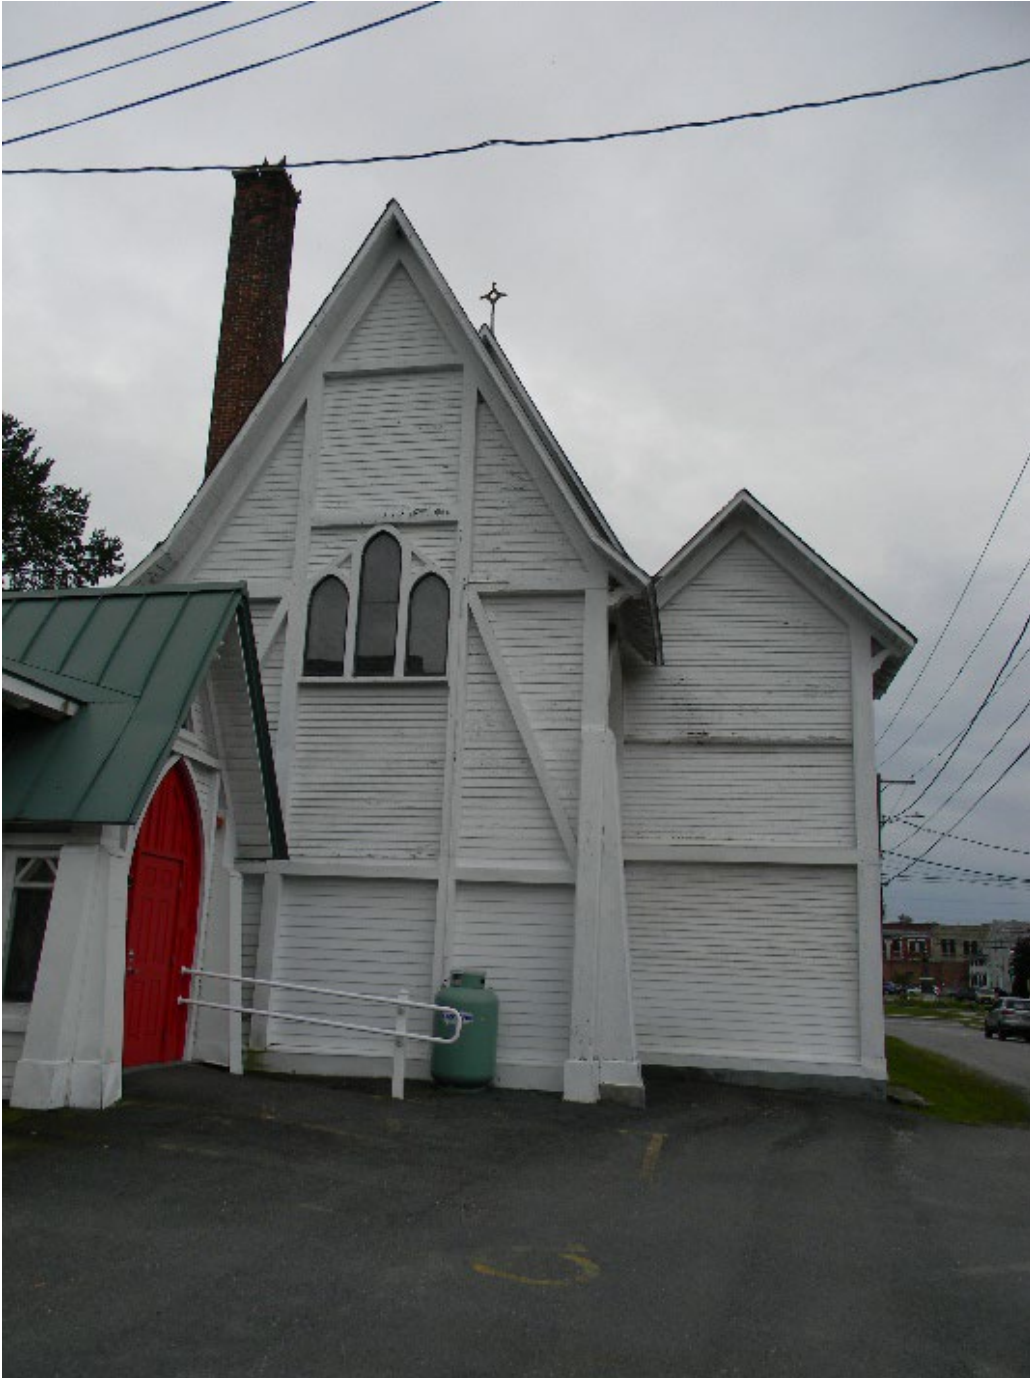
The only accessible entrance is at the north Parish hall entry. It is not ADA-compliant. There is one accessible bathroom and two small non-accessible toilet rooms.

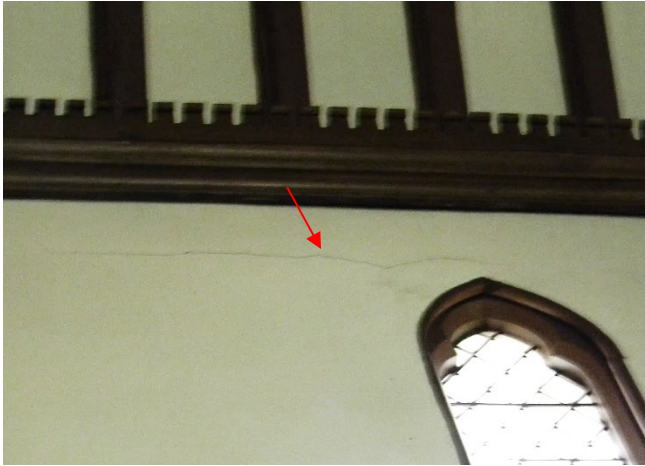
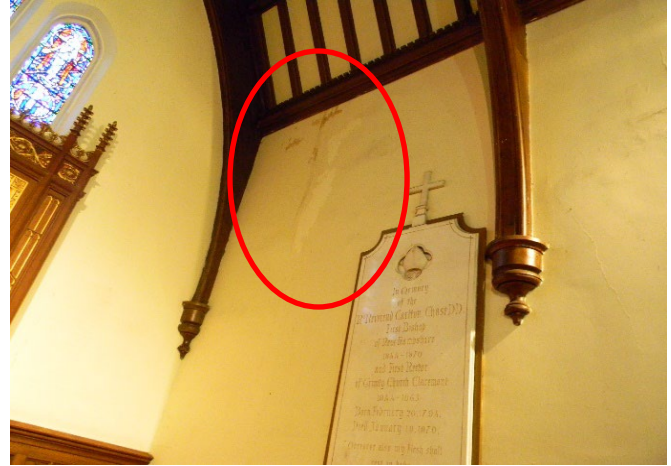
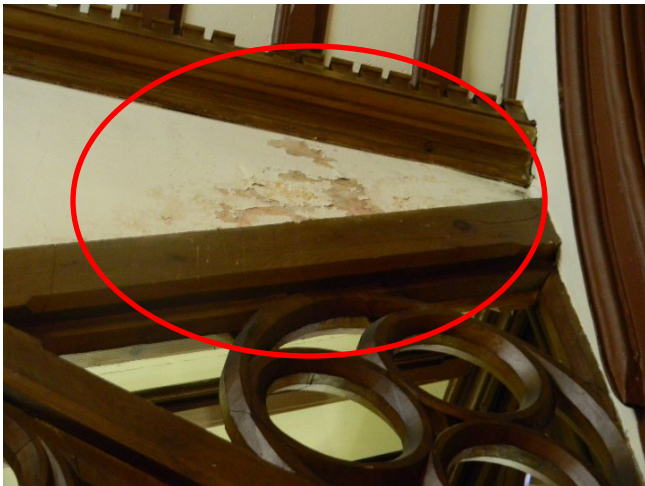
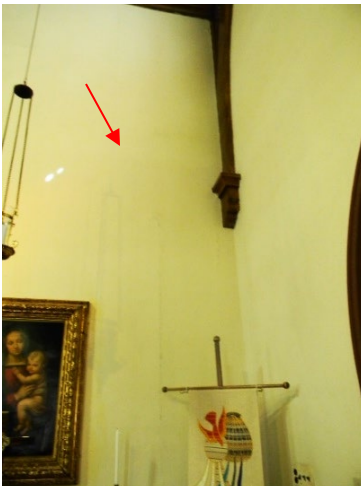
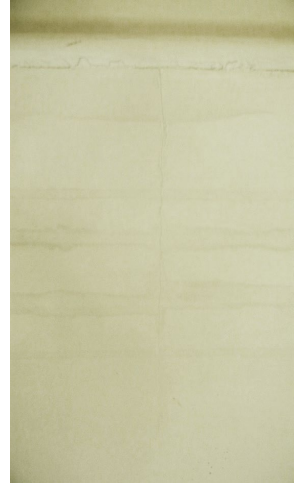
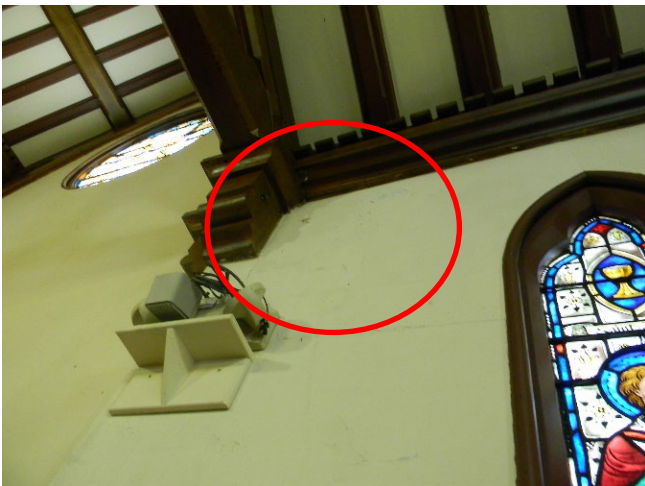
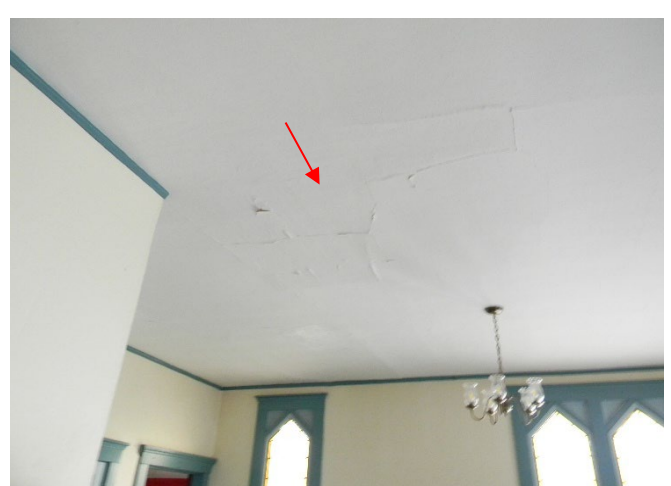
Cracked, stained, bubbled plaster was observed in selective areas throughout the Sanctuary and Parish Hall. Some areas of damage appeared to have resulted from leaks that are no longer active. Most areas of damage correspond to complicated roof junctures / areas of improper roof drainage on the exterior. Hairline plaster cracks at upper level windows in the Sanctuary are likely due to roof movement when stressed by wind or load.

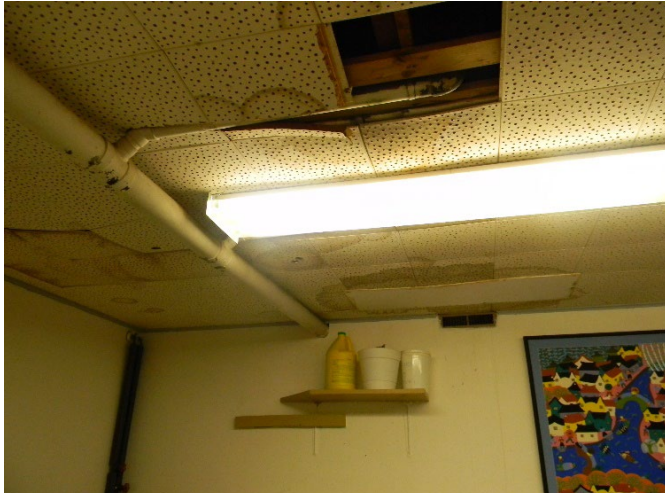
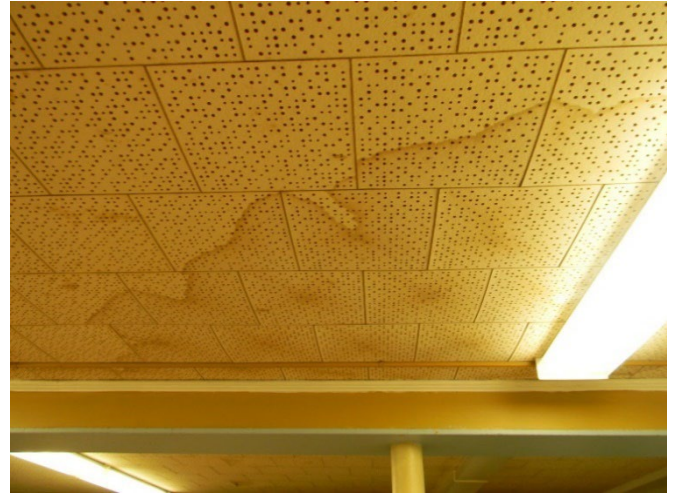
Water-stained ceiling tiles throughout the Basement are reported to have resulted from an interior plumbing issue that has since been repaired.

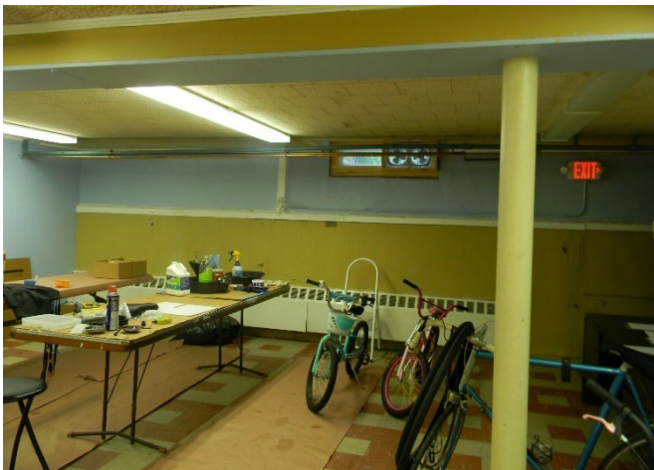
Staining and peeling paint was observed along the Chapel basement south wall.

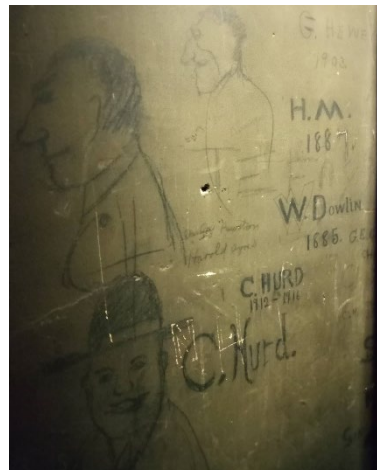
19<sup>th</sup>-century graffiti on the Organ Room wall should be preserved

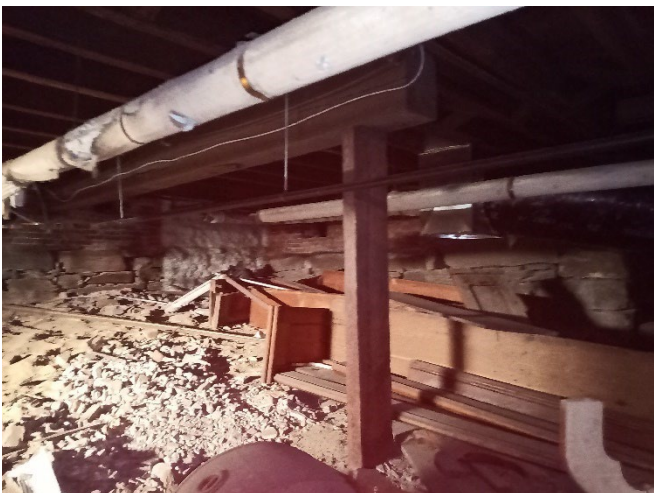
View of Basement beneath Sanctuary

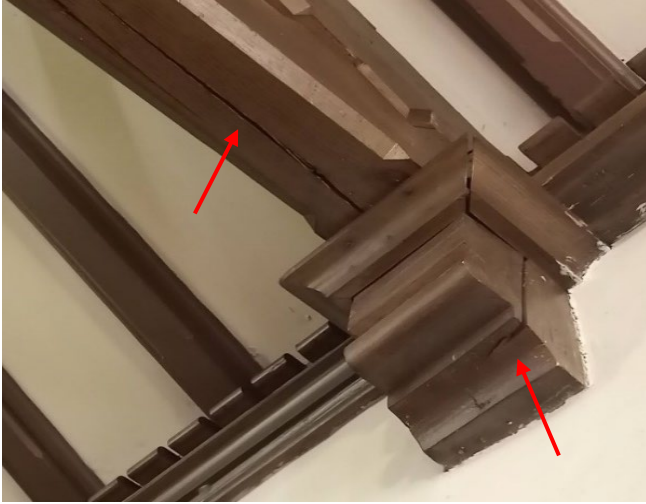
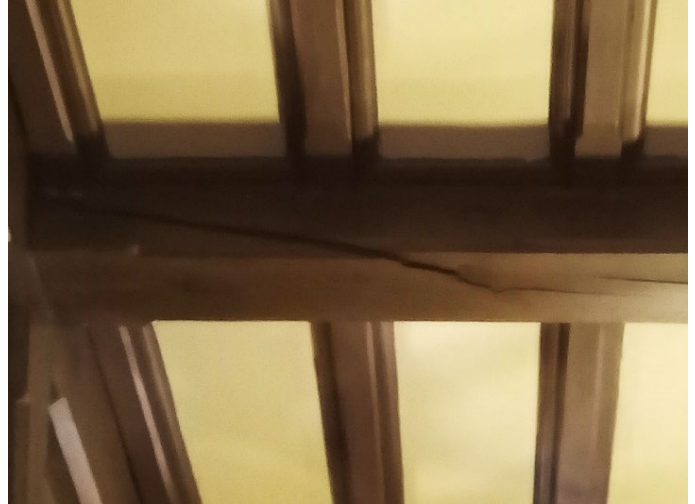
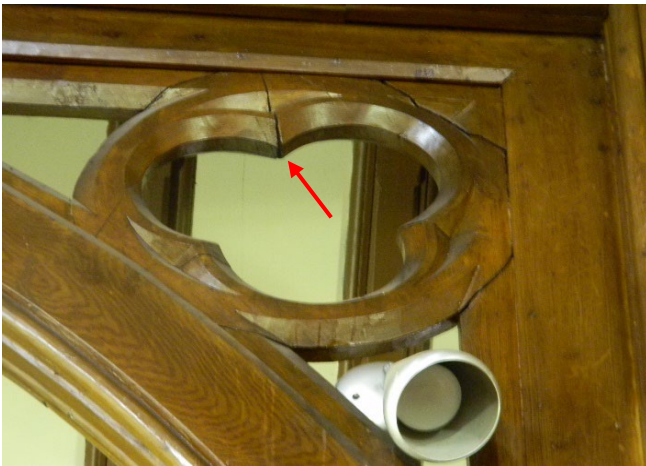
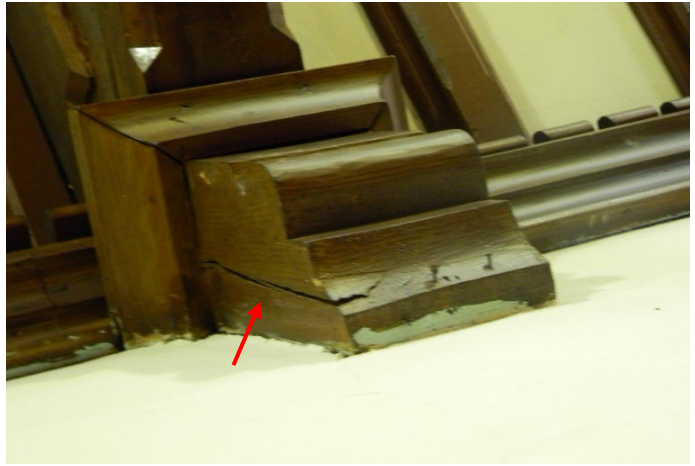
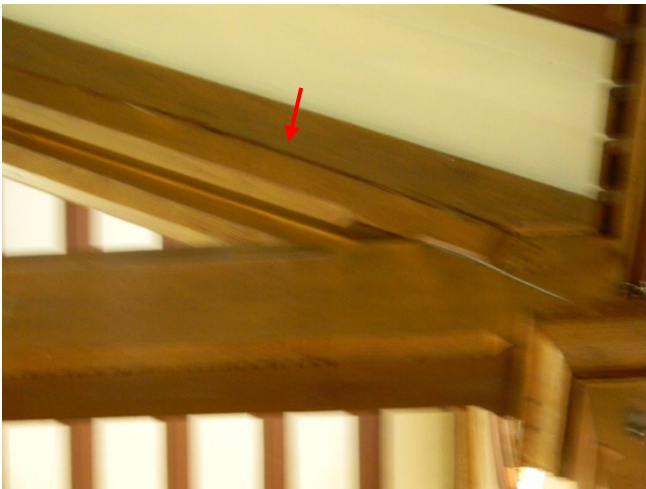
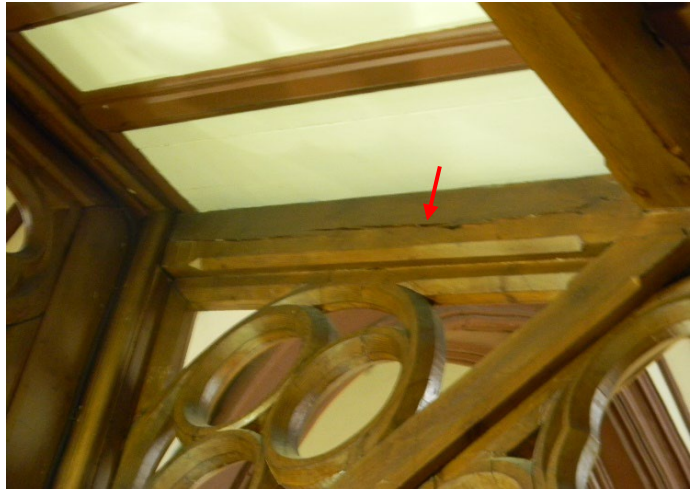
**PART III. – EXISTING CONDITIONS ASSESSMENT**
