NORTH COUNTRY ARCHITECT  
P.O. BOX 609  
FRANCONIA, NH 03580  
[info@northcountryarchitect.com](mailto:info@northcountryarchitect.com)

## HISTORIC BUILDING ASSESSMENT FOR THE

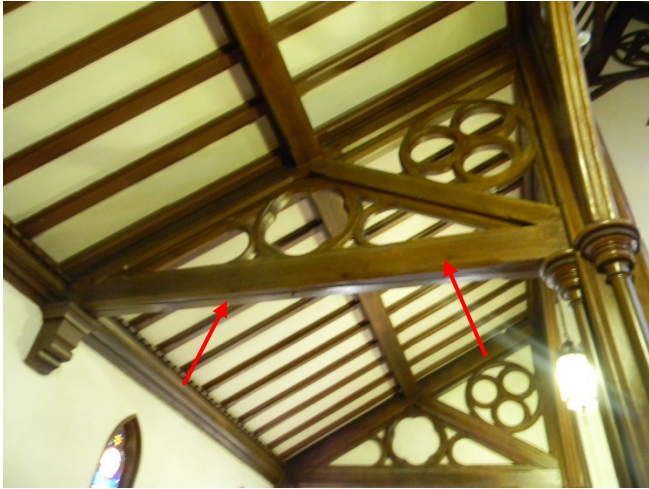
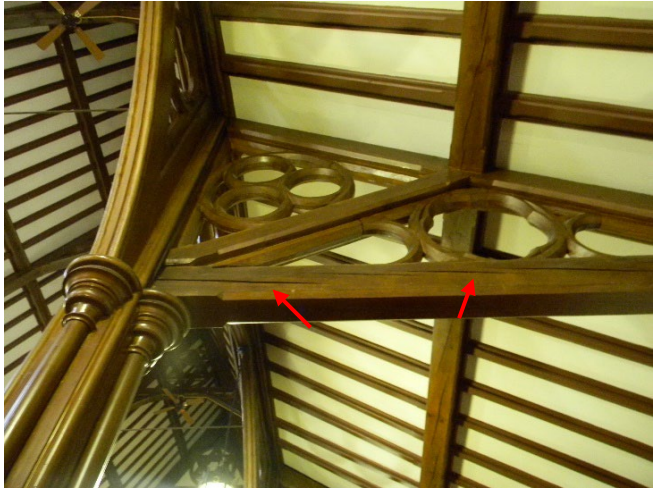
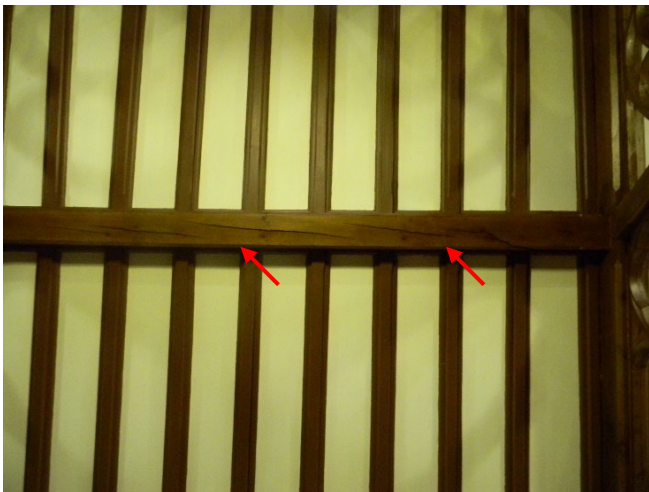
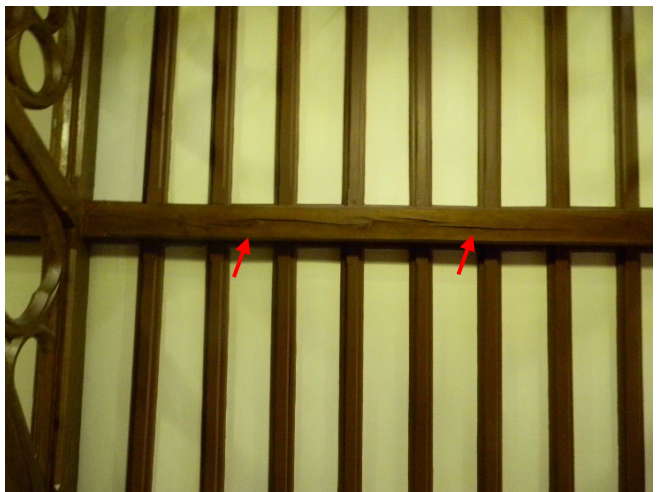
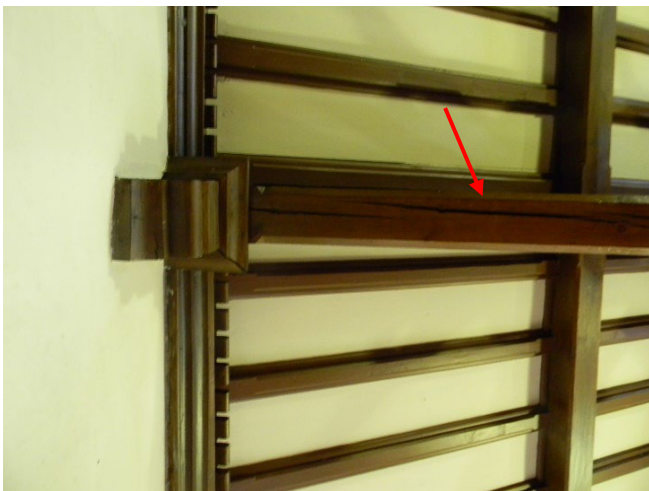
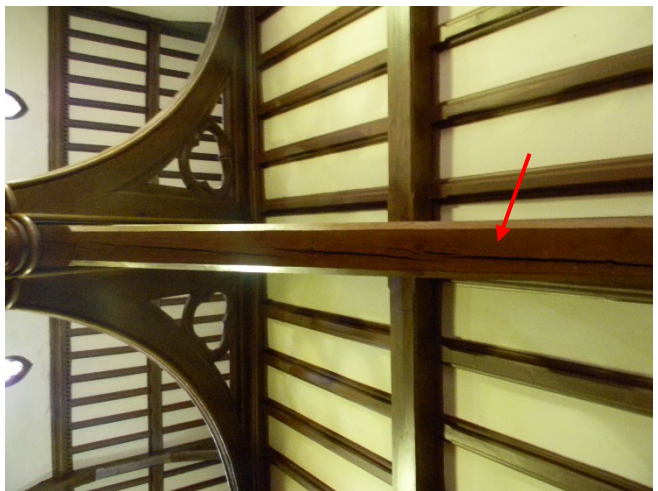
**PART III. – EXISTING CONDITIONS ASSESSMENT**

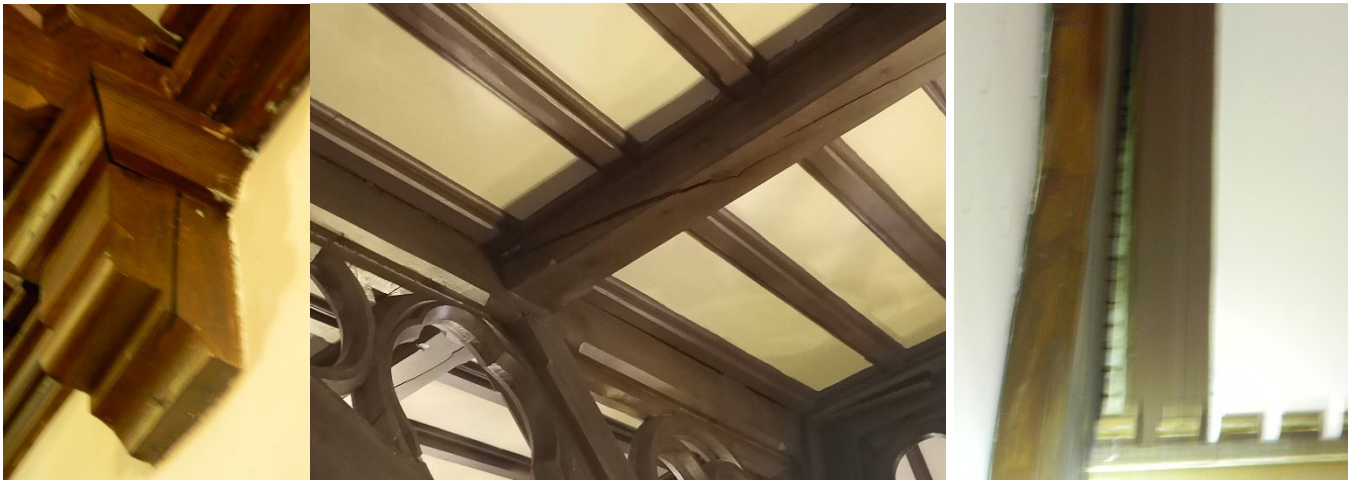
Cracking throughout the Sanctuary roof timber structural elements

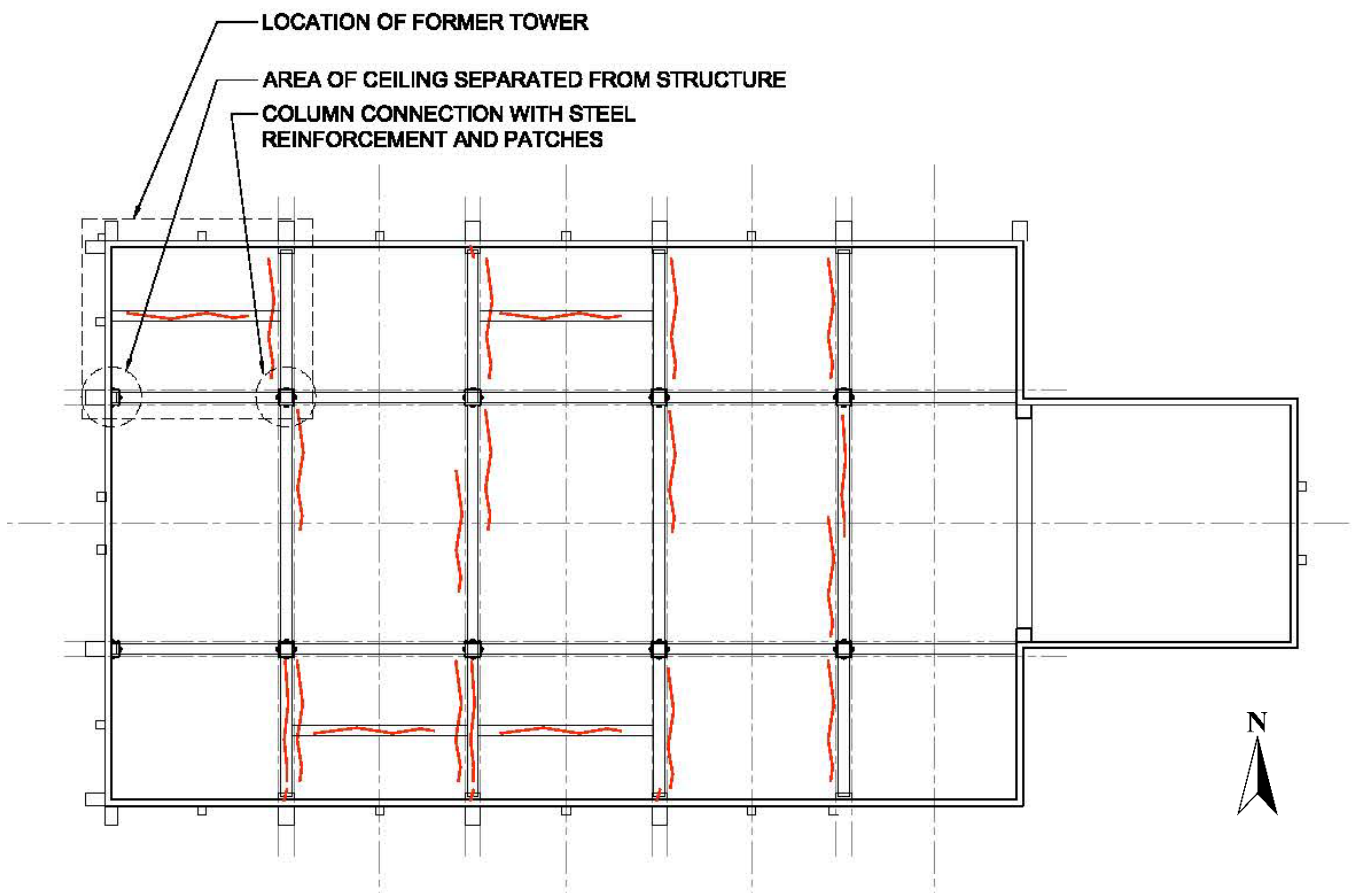
Diagrammatic Structural Plan documenting cracked timber structural elements observed in 2023

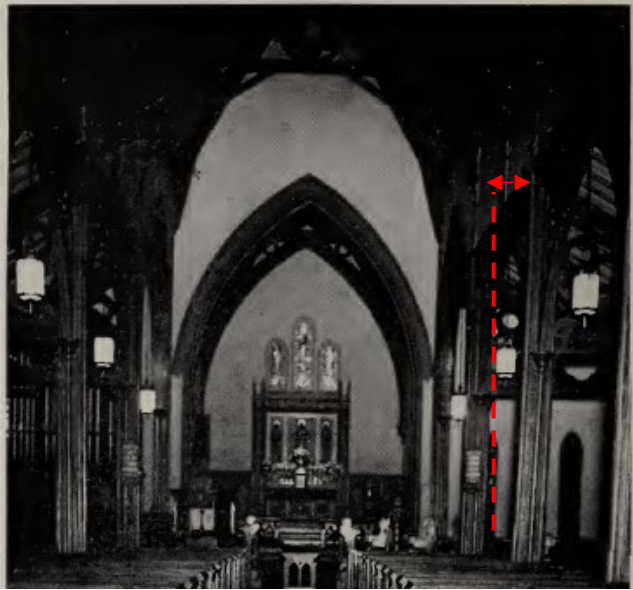
Sanctuary 1943, no tie rod, column leaning outwards

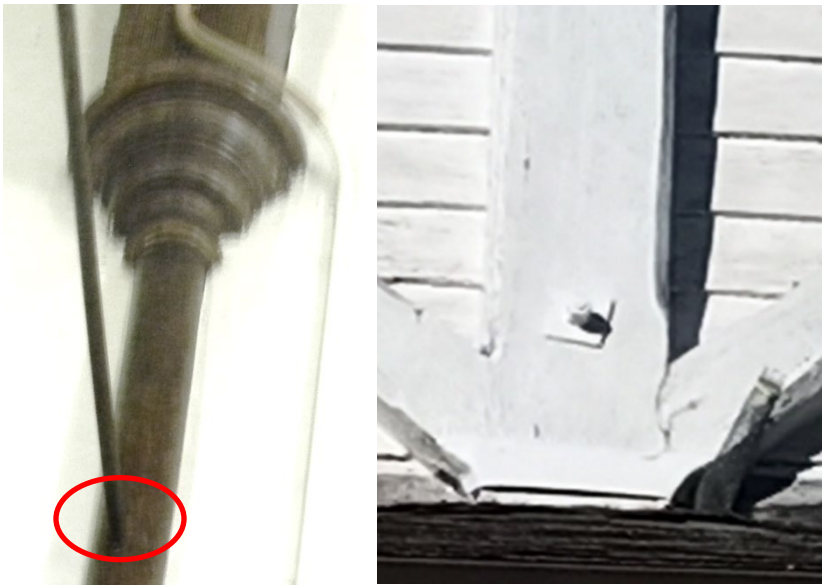
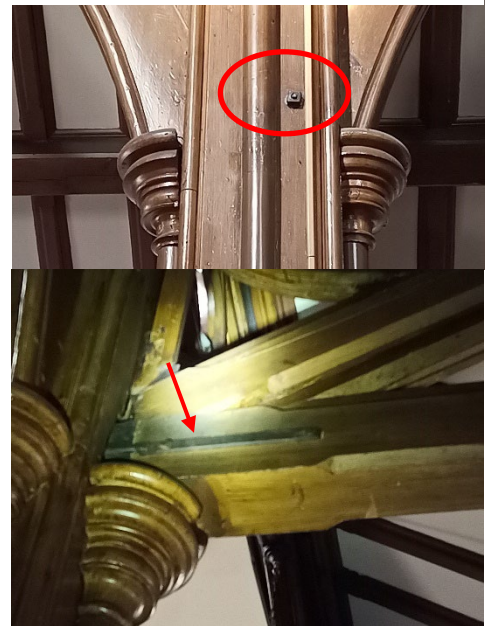
Above left is a view of the tie rod piercing the center of a timber column and right is a view of that same tie rod fastened on the exterior with a flat square plate and bolt.

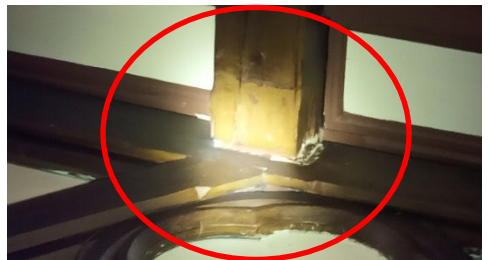
### **PART III. – EXISTING CONDITIONS ASSESSMENT**

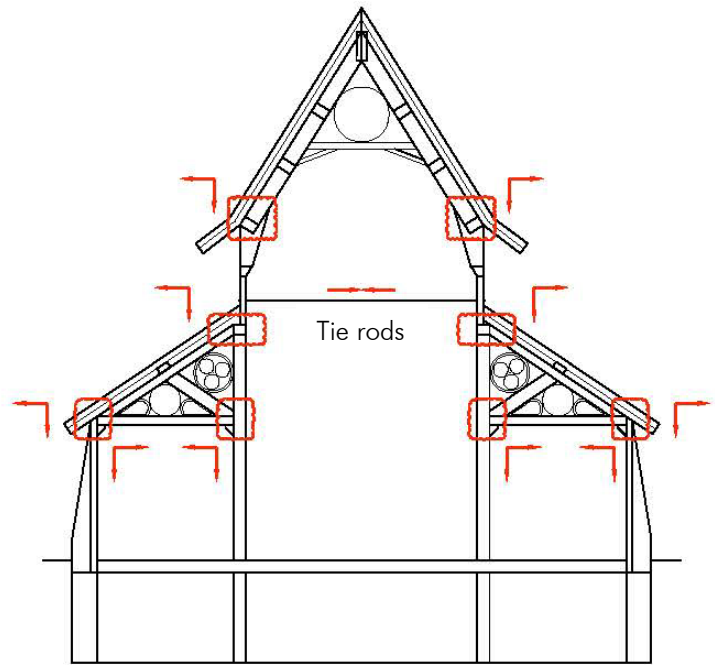
Diagram of stresses acting on roof structure and joints to be examined further.

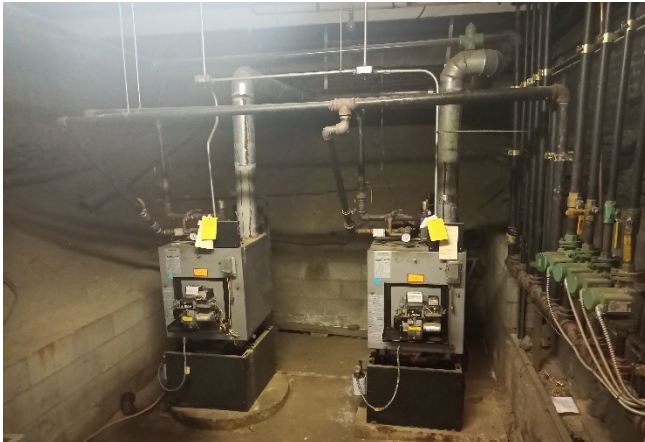
Oil-burning furnaces

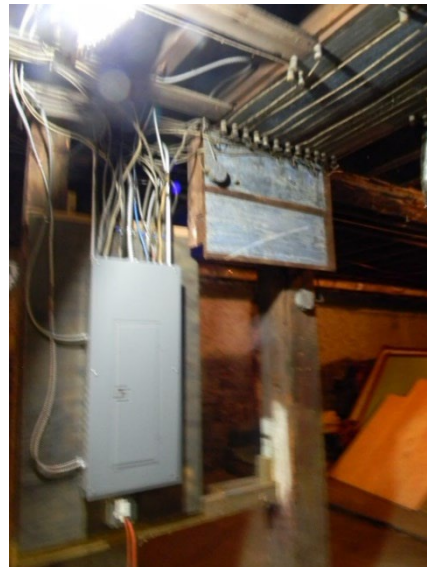
Mix of modern, 2-wire, and old knot-and-tube wiring

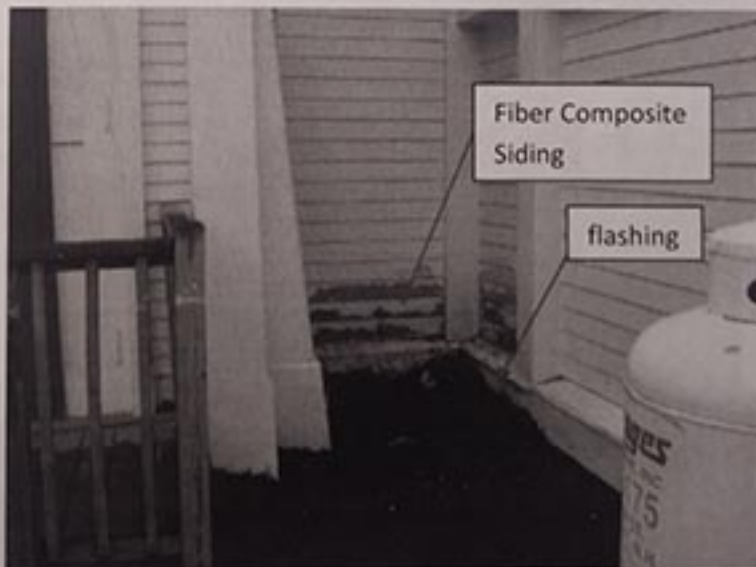
Figure 1: Flashing and siding maintenance have staved off deterioration in this wet area where paint won't hold but siding and sill are sound.

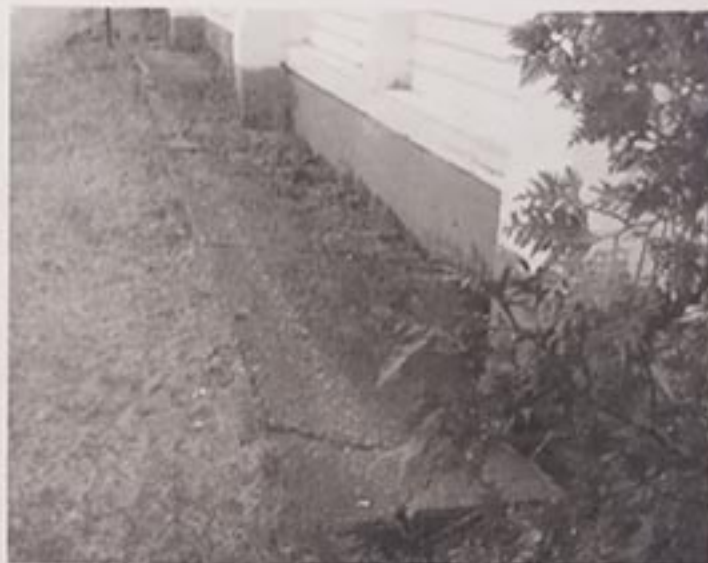
Figure 2 Northwest corner splash pad slopes toward building directing roof runoff to foundation.

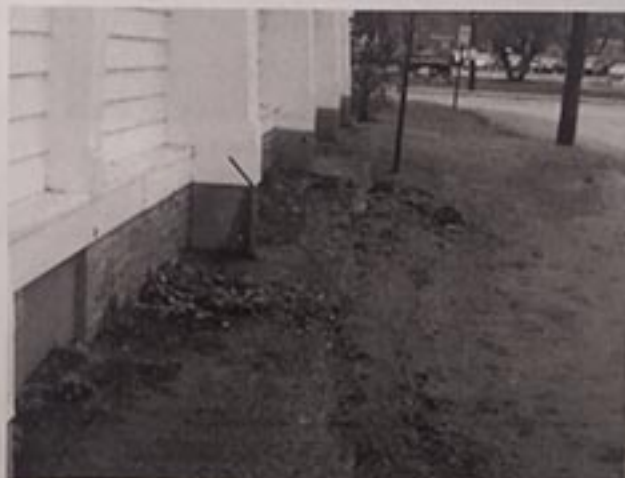
Figure 3 Moss and debris impede runoff

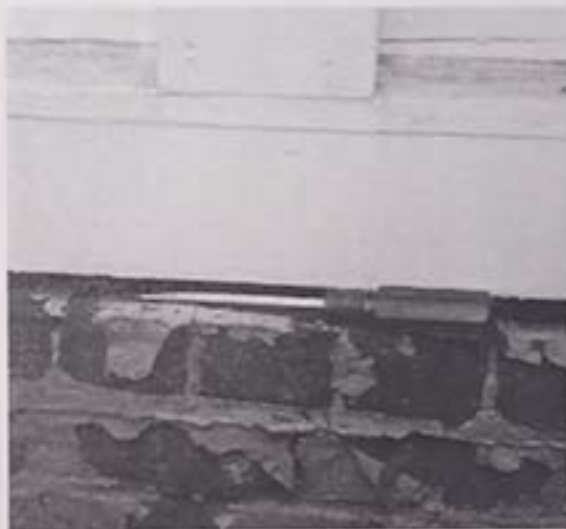
Figure 4 Loose brick on exterior and large separation between sill and foundation

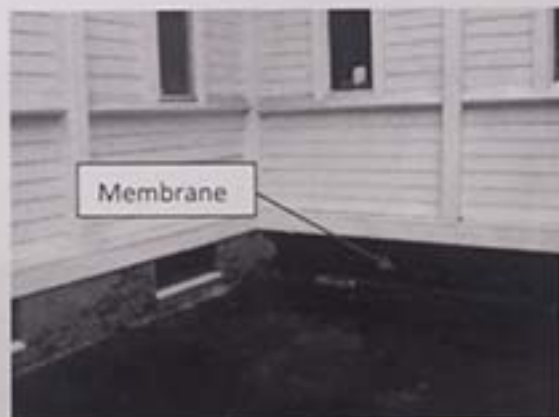
Figure 5 Brickwork has been fitted with a membrane under this roof valley.

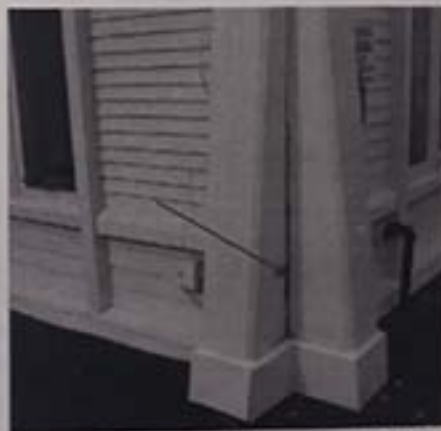
Figure 6 Separated cladding exposes timber column inside

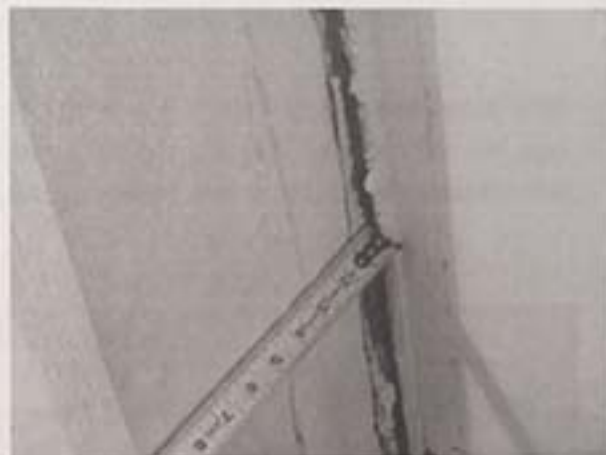
The building has two attic spaces; one over the kitchen and one south and east of the sanctuary. The church bell is located in the attic space south and east of the sanctuary. Both attics were found to be dry. Neither attic revealed signs of moisture. The wood framing observed was sound with not obvious deformation.

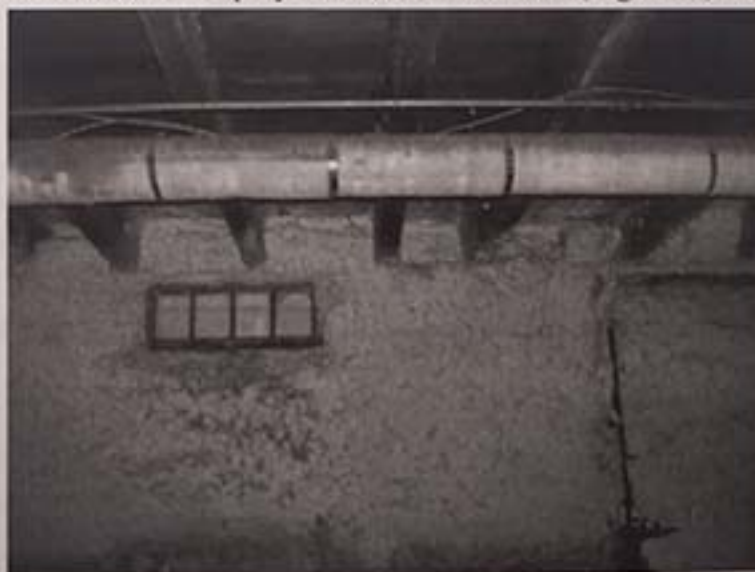
Figure 8 Insulation covers sill and wall but sill, joist and masonry resisted penetration wherever checked.

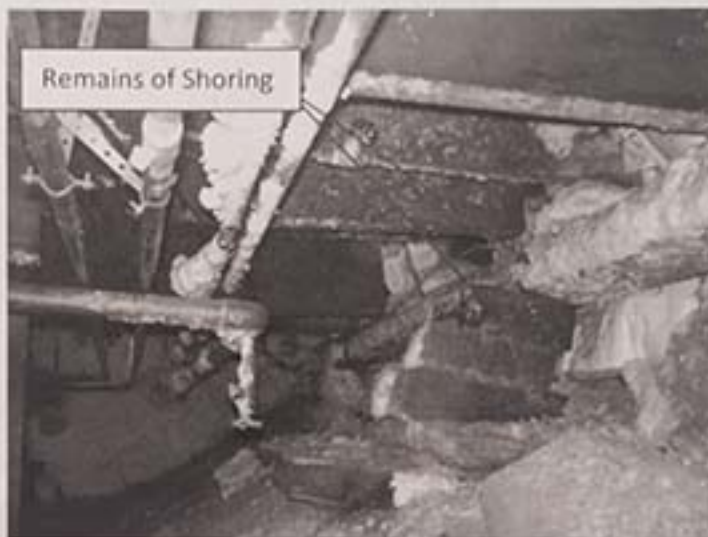
Figure 9 Plumbing, rubble, and insulation prevented closer observation of this north crawl space wall. Once shored these joist connections could not be observed

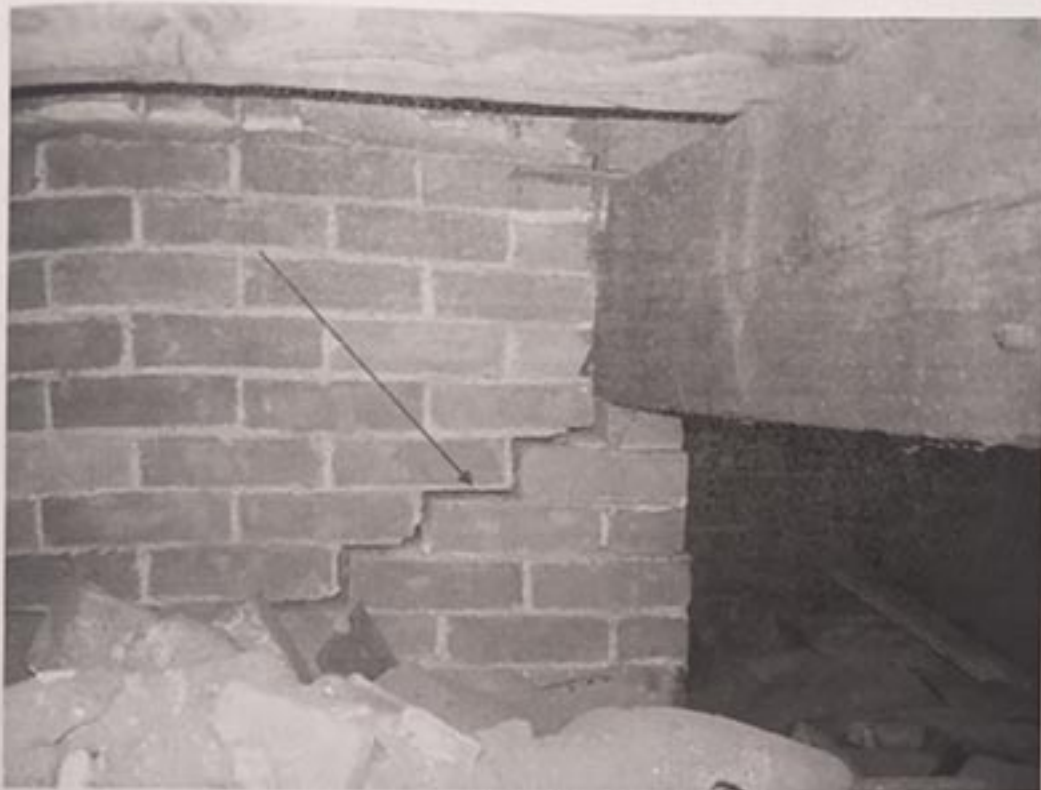
Figure 10 Bearing wall in failure.

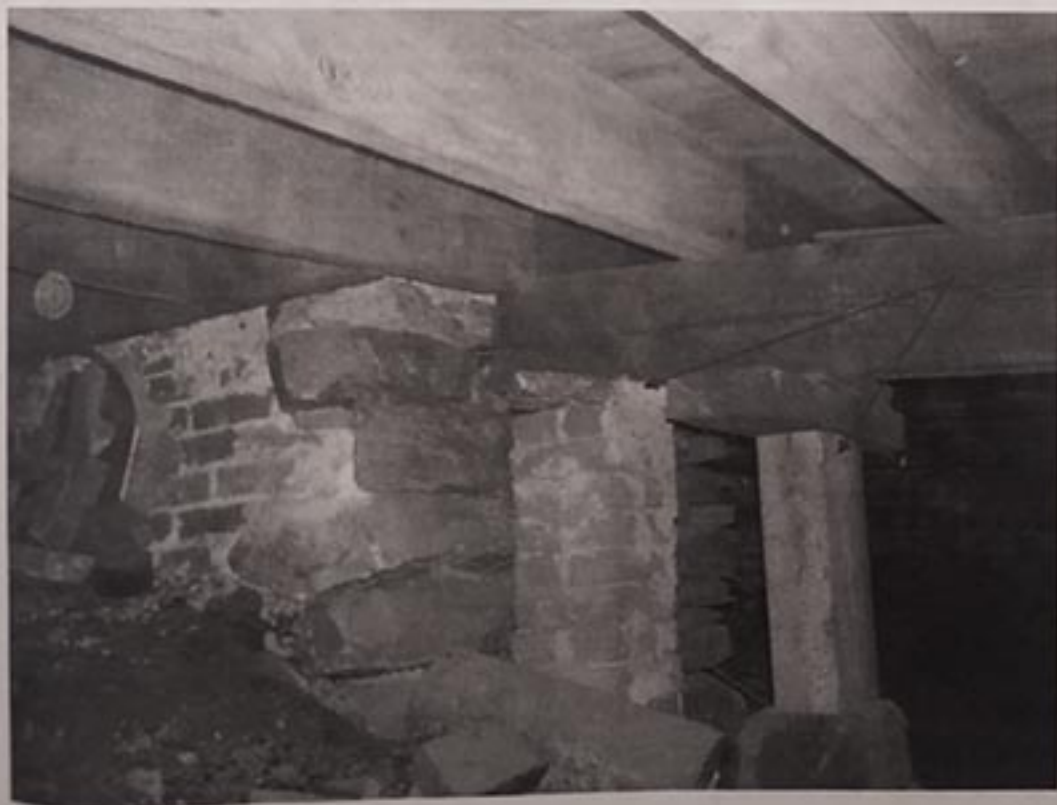
Figure 11 Bearing & Support lack fixity and lateral stability.

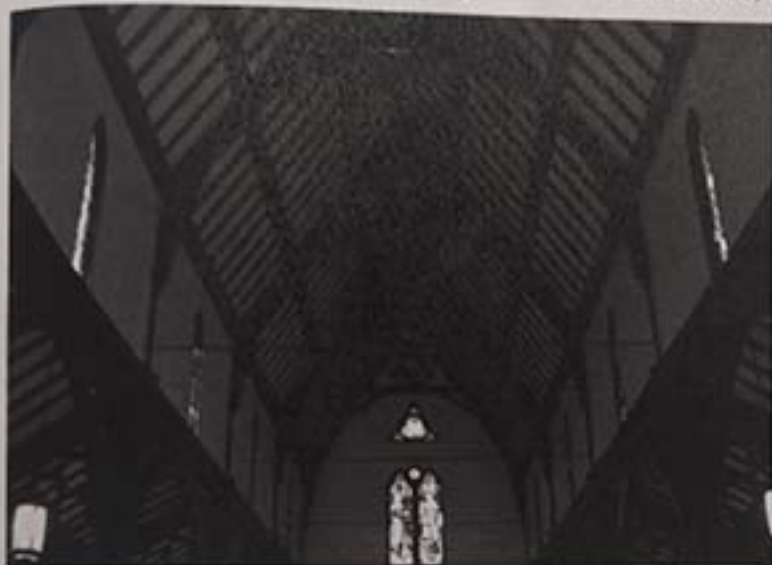
Figure 12 Vaulted Center Roof with flanking Lower Roofs. Horizontal Ties connecting to columns.

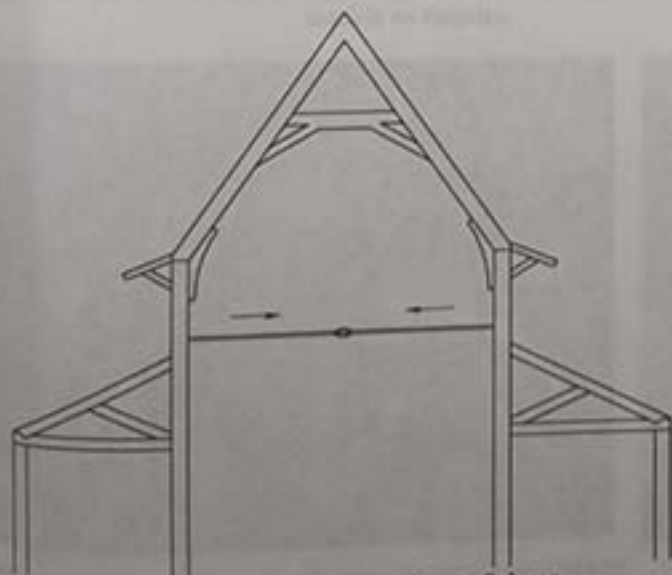
Sketch 1 Tension in Tie transfers to Column. (Not to Scale)

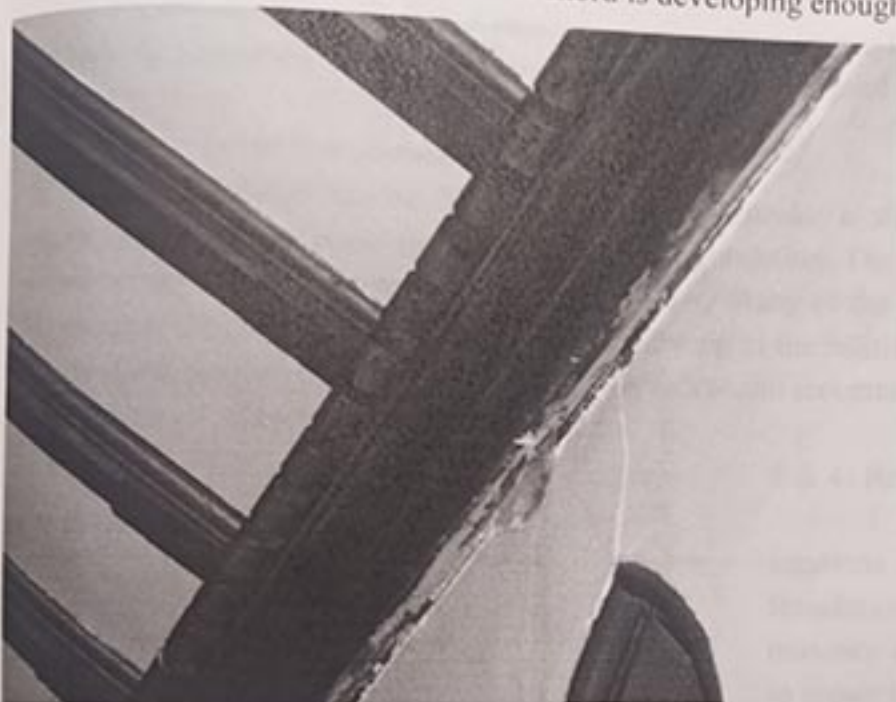
Figure 13 Loose Plaster at cornice, owing to the window size and shape, the plaster crack is no surprise.

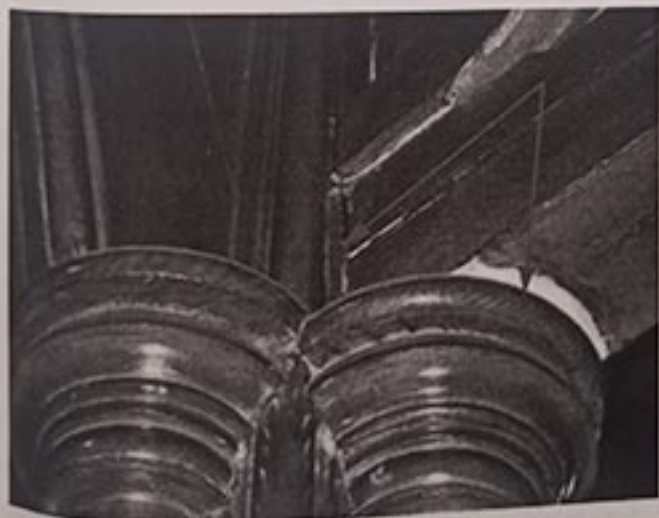
Figure 14 Lack of Stain suggests Bottom Chord has moved  $\frac{1}{2}''$  to  $\frac{3}{4}''$ . It is not clear how the chord connects to the Column.

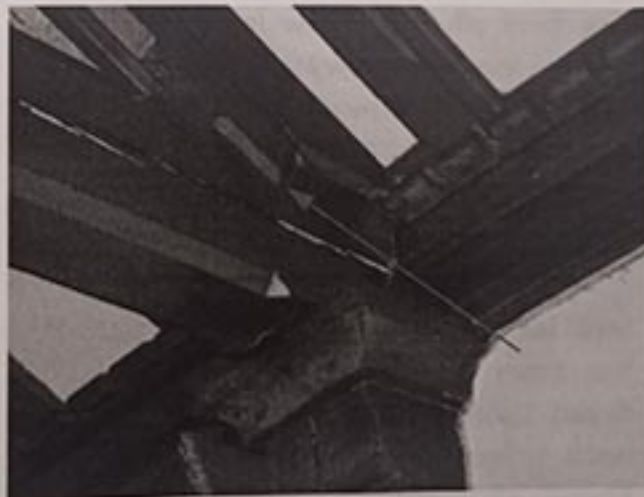
Figure 15 Exterior Timber connection of Bottom Chord is designed to transfers thrust into Tension in Bottom Chord.

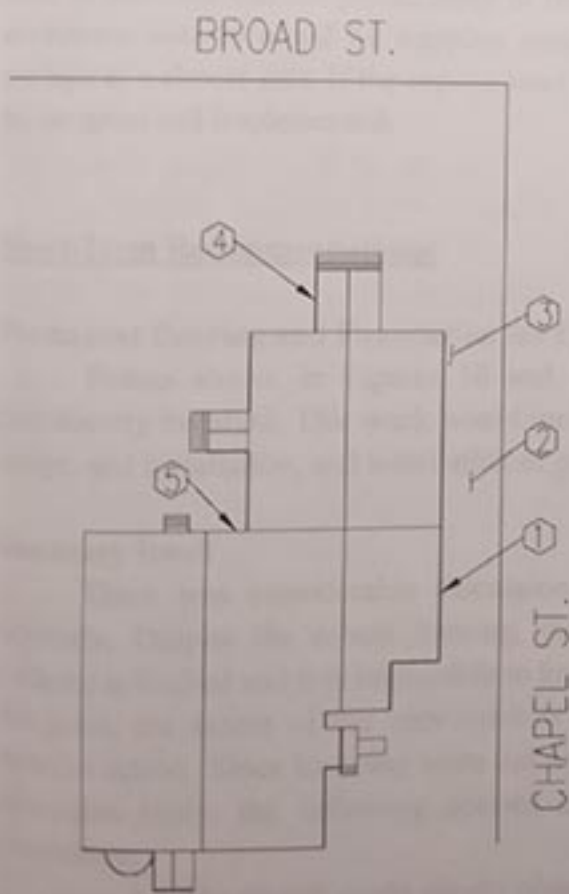
**1 & 4: Repair Brickwork**

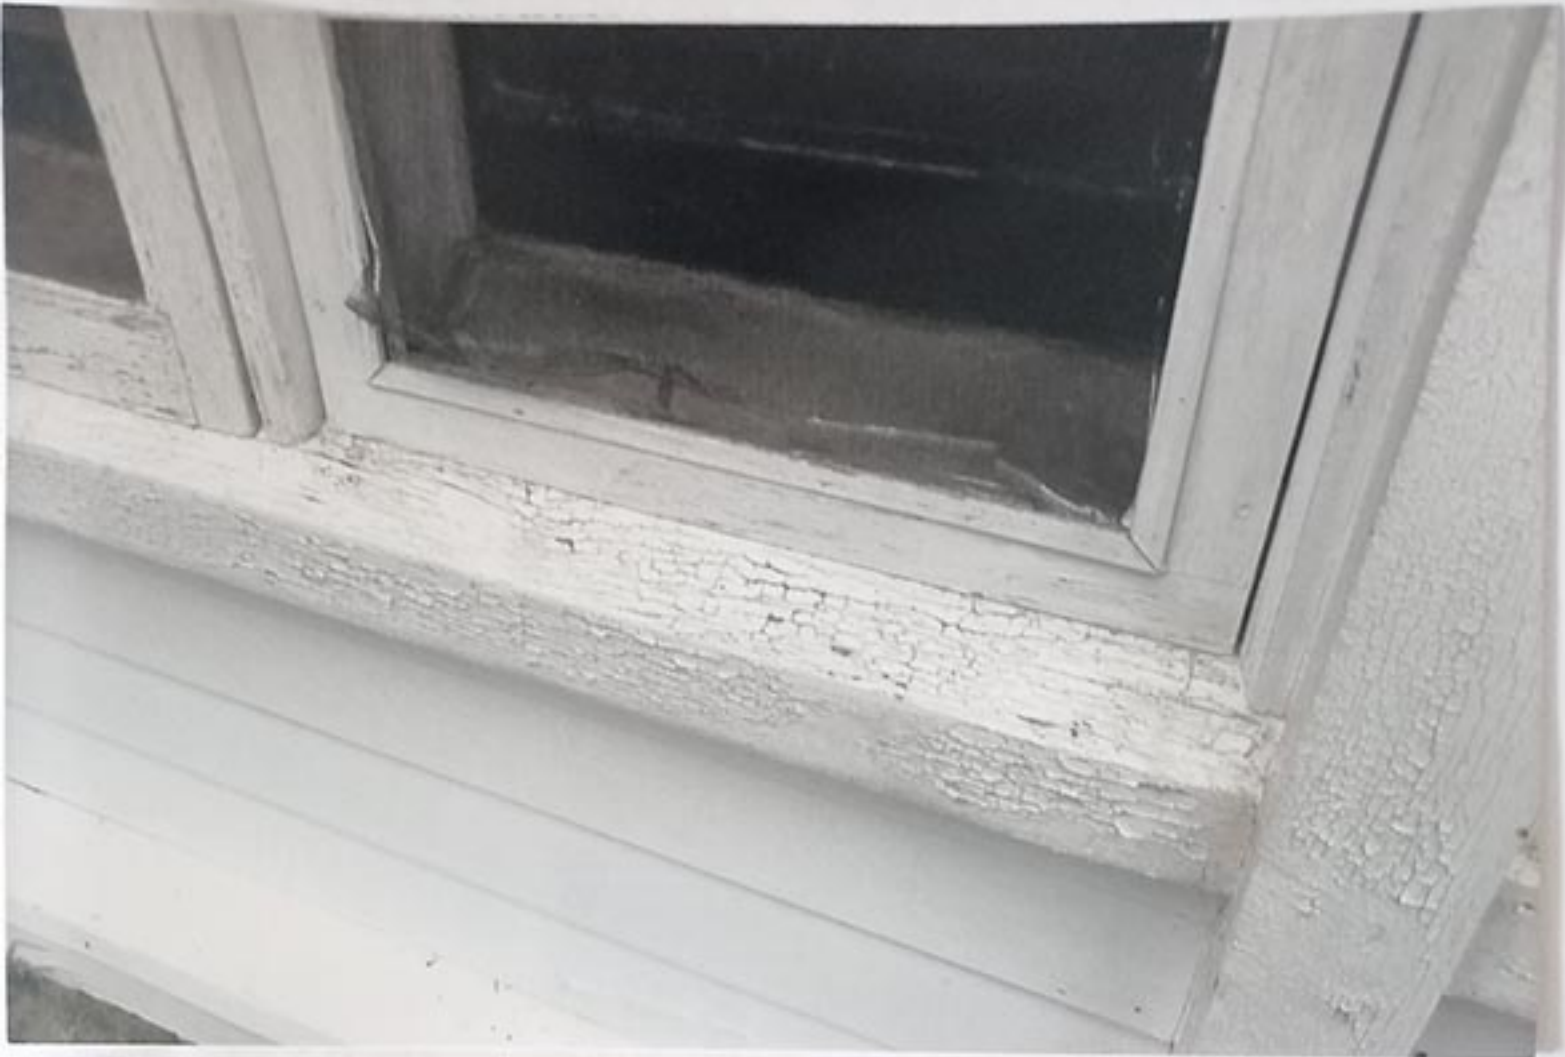
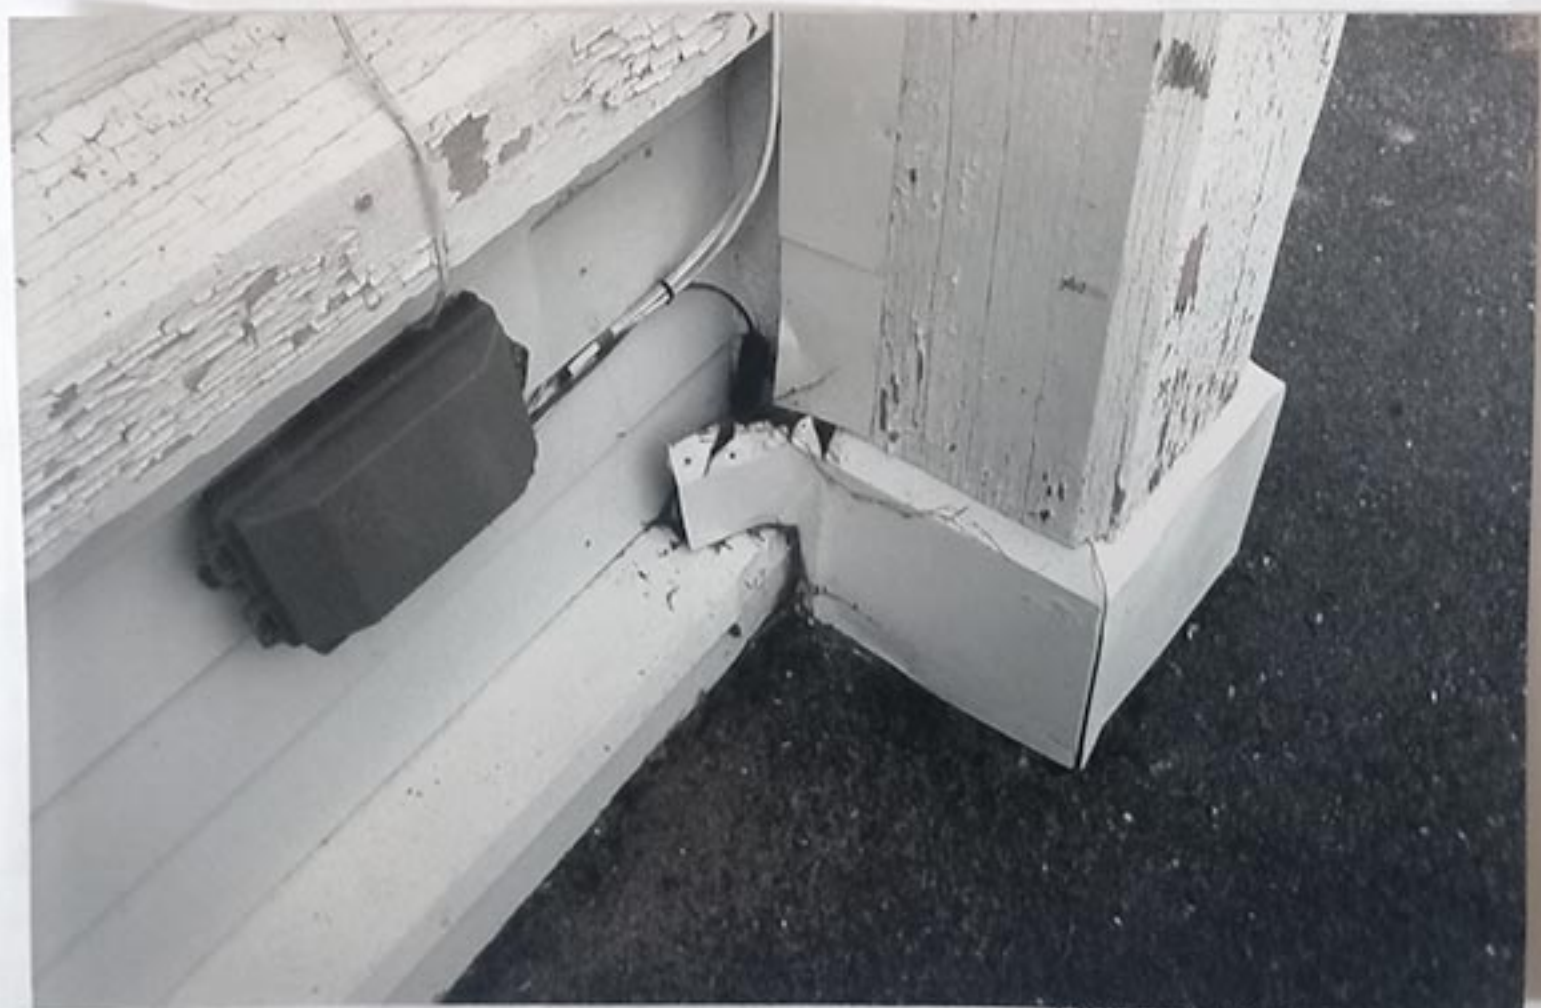
Generally speaking, given the age of the structure, the church is in good shape. There was no profound evidence of rotted wood or moisture inside the structure, its basement or crawl spaces. The structure's health is testament to diligent maintenance and care over the years. Continued diligence and care will preserve this unique structure for many future generations.

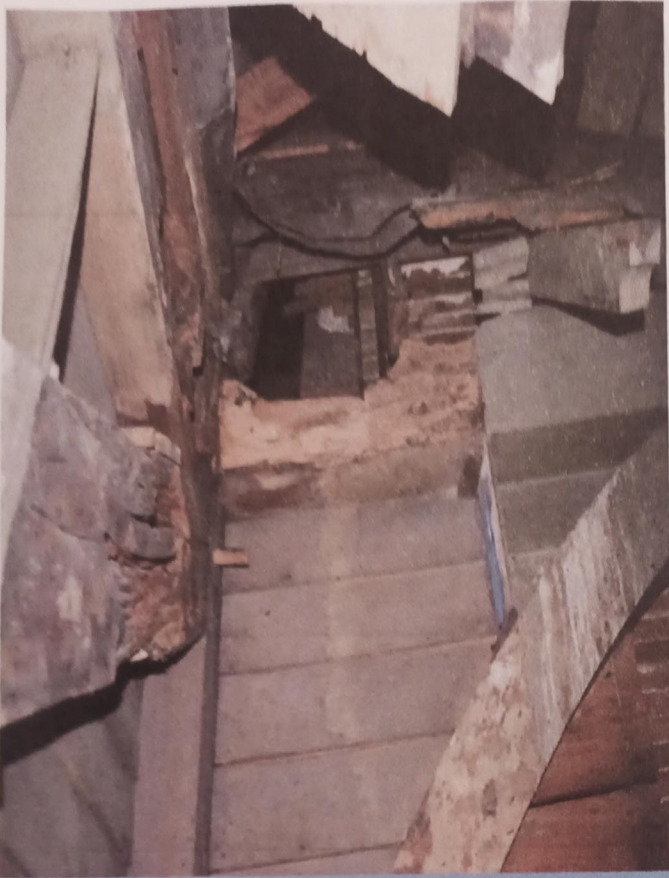
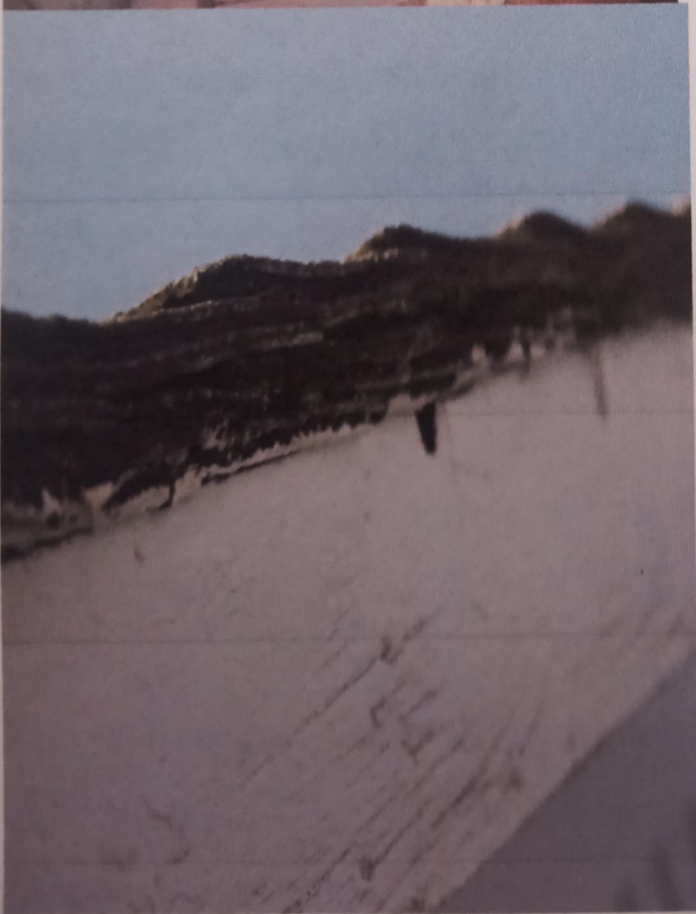
10. Windows need replacing on office building. Estimated cost of repair \$5,000. timeframe to complete, 3 years
