## **Structural Report**

**Trinity Episcopal Church  
120 Broad Street  
Claremont, NH**

22 October 2025

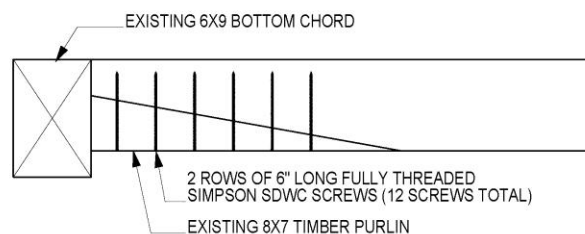
#### **PROPOSED REINFORCEMENT OF SHED ROOF PURLIN**

That being said, the torsional crack in the timber purlin that Beth Miller pointed out on page 39 of her report has a significant 'slope' to its grain (runs at a significant angle to the long axis of the purlin). This means that a fair number of wood fibers are discontinuous which reduces that beam's strength capacity. It has been recommended to the church board to have this beam reinforced with 12 fully threaded screws (with minimal head sizes) from below, in order to make the split wood sections function as a unit again. A drawing detailing this reinforcement design is shown below. Since it seemed wise to reinforce this purlin sooner rather than later, the board has already acted on the proposed reinforcement scheme and had the screws installed. A picture of the reinforced beam is also featured below.

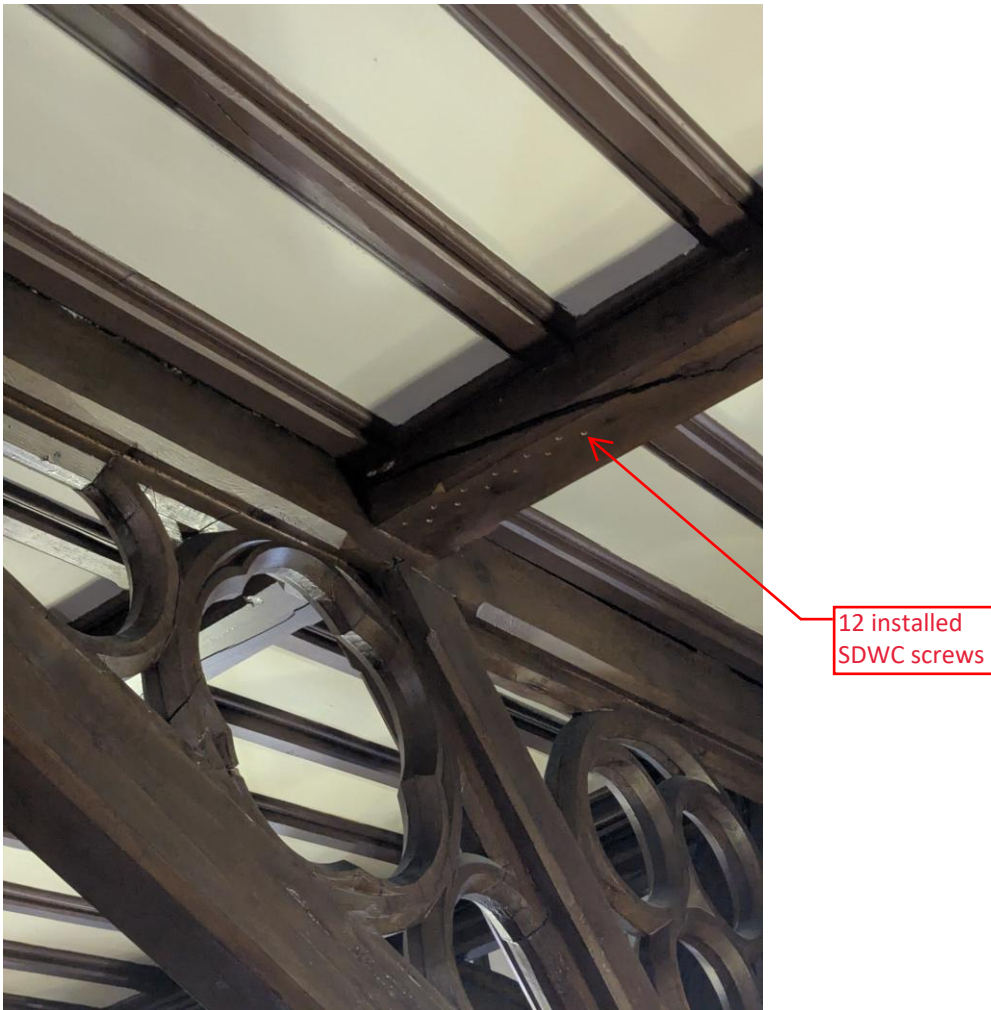
***Picture 1: Shed roof purlin with fully threaded screws reinforcing cracked section***

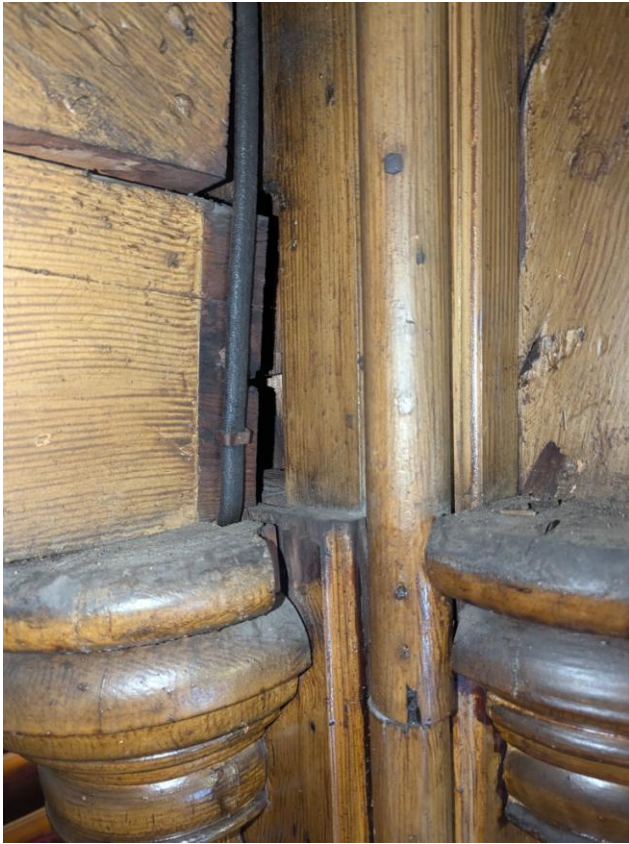
The adequacy of the existing tension connection of those shed roof truss bottom chords to the center aisle posts has been subject to much speculation over the years (see also the highlighted section on page 8 of Goldknopf's structural report attached to this report). The lack of stain at some of the bottom chords and/or open gaps where they bear on the corbel block of the center aisle posts seem to indicate that at least some of the bottom chords have pulled away from the center aisle posts by as much as 3/4" (see pictures 2 and 3 below). This would also explain why the southern eave wall appears to be leaning outward at the top when sighted along the inside.

**Picture 2: Bottom chord of shed roof truss has pulled away from center aisle post**

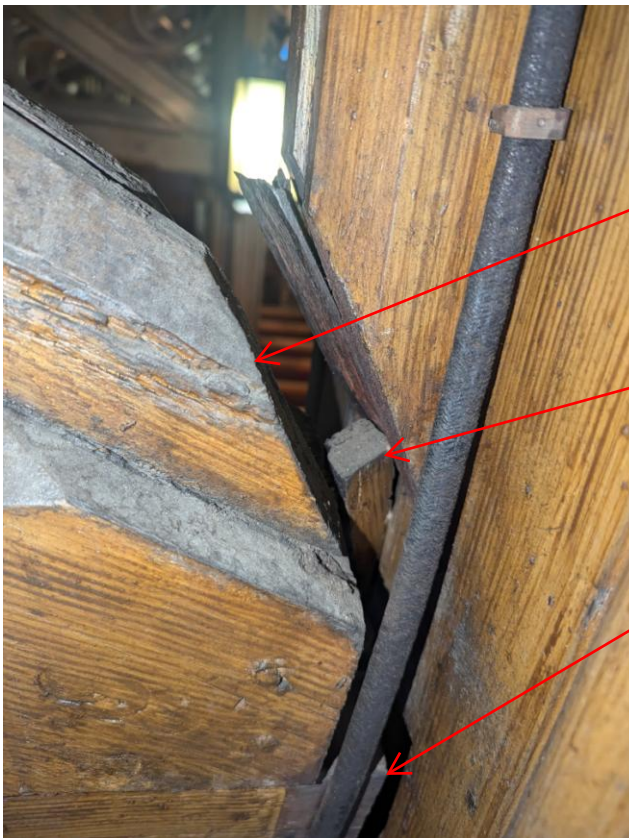
Diagonal strut (in compression) pulled away from center aisle post with bottom chord

Wedged shim, installed presumably to transfer compression force into post again

Bottom chord pulled out of housing in center aisle post

**Picture 3: Diagonal strut and bottom chord pulled away from center aisle post**

Based on our recent non-destructive observation of those joints, with a scope camera and a light directed into the existing gap between the end of the bottom chord and the (ornately trimmed out) center aisle posts, there is some evidence that the original joint consisted of a mortise and tenon joint. However, based on the amount of lateral movement of the bottom chord (as evidenced by the extent of the non-stained portion of the bottom chord out of the joint) and the slightly outward tilting eave walls, it seems likely that either the end grain of the mortise has sheared off, or that the pegs have snapped in the mortise and tenon joint.

Since it appears that at least some of the various trim pieces surrounding the tension joints in question might break if they were temporarily removed, Annette Dey Engineering LLC recommends a semi-visible reinforcement method that would not require the removal of the existing column trim. It has basically been designed along the lines of the one existing joint that has been reinforced in the past (at the inside corner of the former tower location). As can be seen in the two pictures below, a strap that was welded to a threaded rod was fastened to the face of the bottom chord, extending through the column and is pulling against a washer and nut at the inside face of the center aisle column.

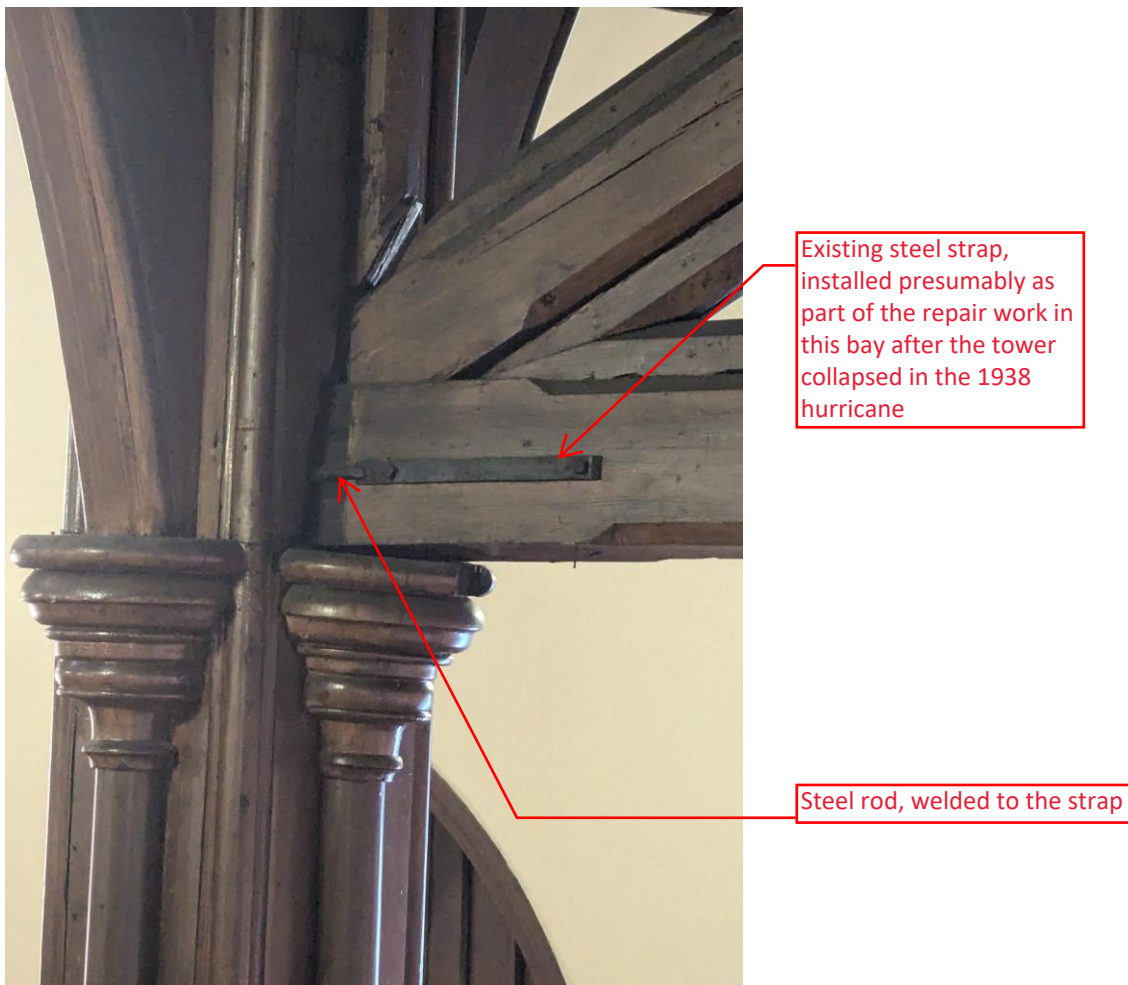
***Picture 4: Existing reinforcement of bottom chord tension joint at northwestern-most center aisle post***

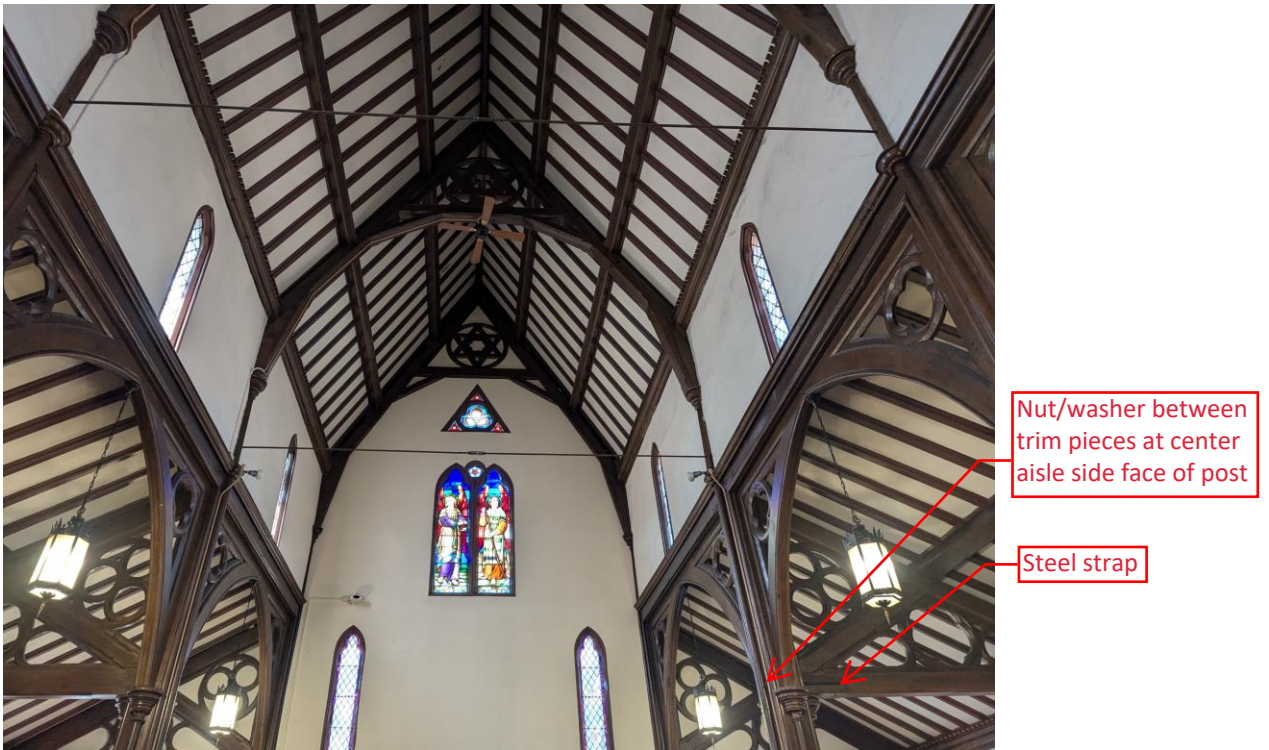
**Picture 5: Installed strap, rod and washer/nut at northwestern-most center aisle post**

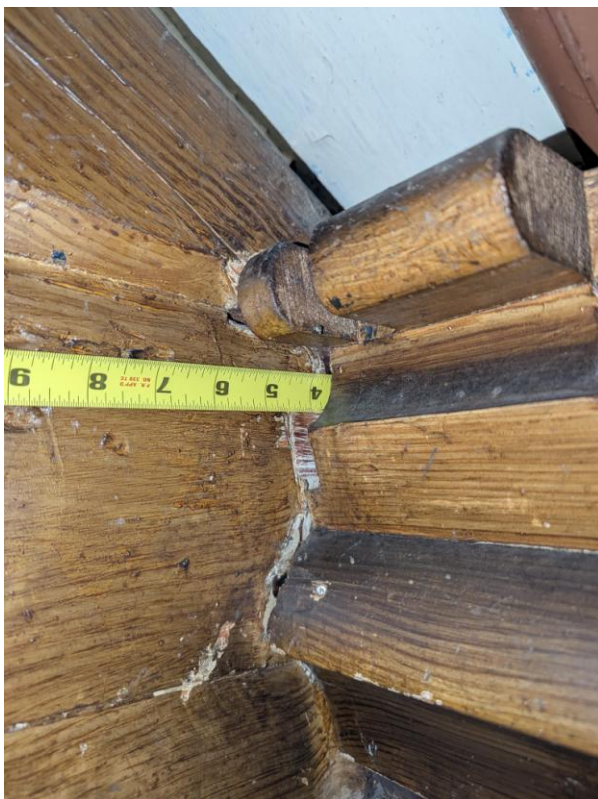
***Picture 6: Bottom chord of shed roof truss extending beyond bolster block into eave wall***

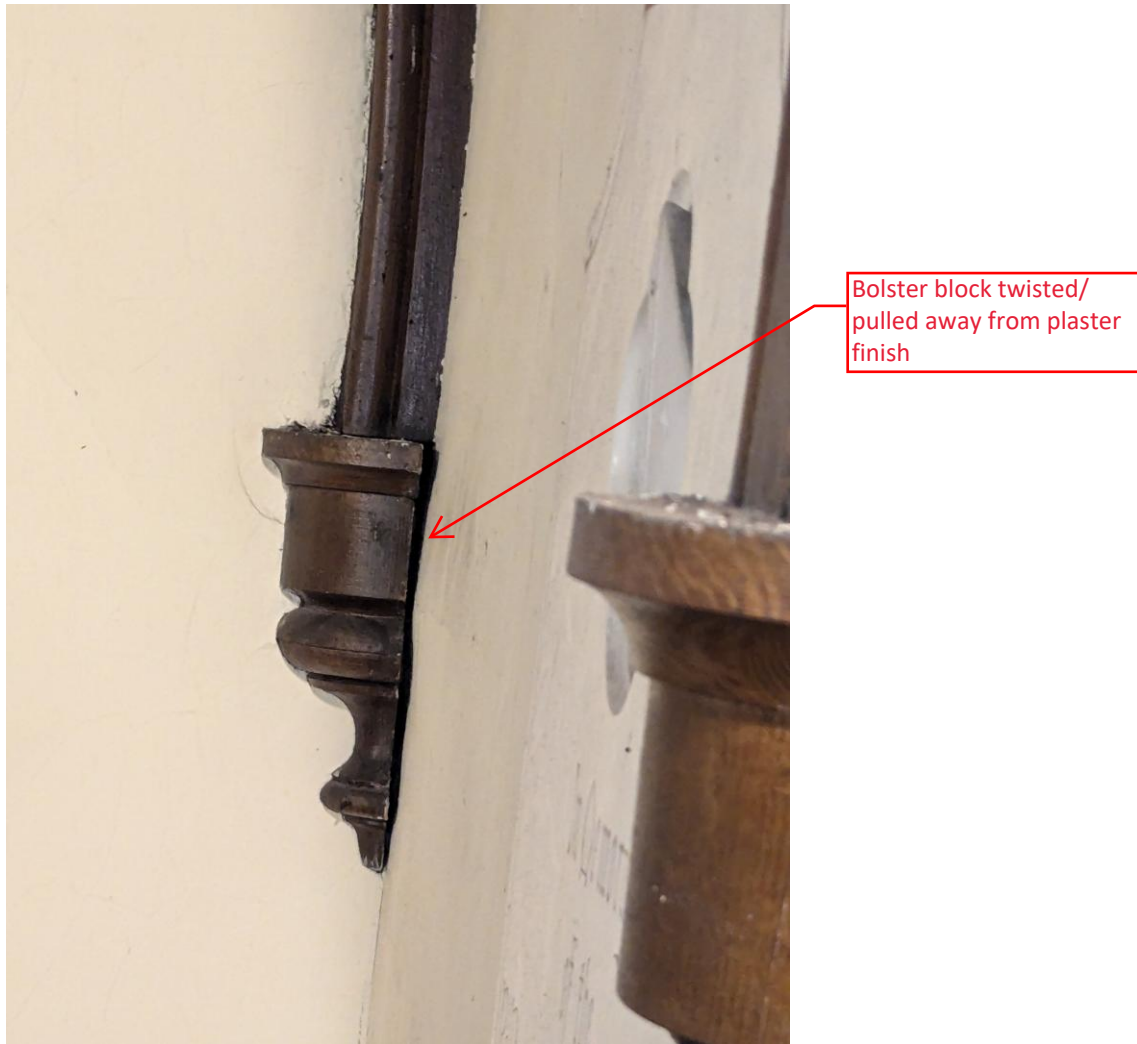
As far as the corbel blocks in the sanctuary go, they appear to be mostly ornamental, since the rafters themselves appear to bear directly in the wall, and only the rafter trim comes down to sit on the corbel blocks (see picture below). Thus the gaps opening up between some of the corbel trim pieces and the wall plaster is not so much of a structural concern. However, they should be observed for ongoing movement and their fastening to the wall framing increased, as needed.

Bolster block twisted/  
pulled away from plaster  
finish

***Picture 7: Corbel block and lower section of rafter trim at southeast corner of sanctuary***

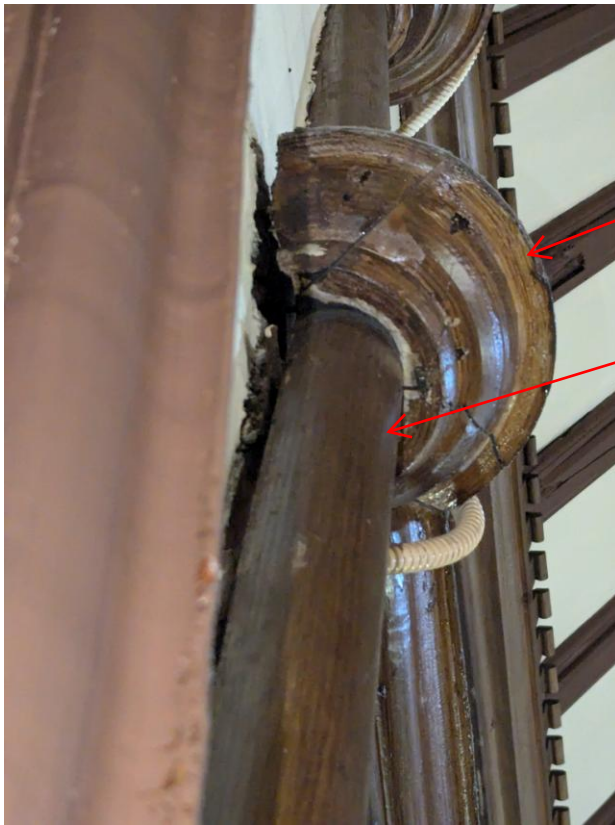
Of the various displaced corbel block trim and center aisle post trim (above the shed roof planes) Annette Dey Engineering is most concerned about the center aisle post at the southeast corner of the nave (see location indicated on hardware layout plan, above). The picture below shows how the portion of the center aisle post trim above the shed roof plane has been significantly displaced relative to the upper portion of that post trim. It is possible that we are seeing the effect of the center aisle post getting pushed outward significantly at the (upper) eave joint before the adjacent building was constructed (for reference see the lateral displacement potential in the original timber bents indicated in the analysis files attached to this report), in which case the installation of the proposed additional steel rod in this bent should serve to ensure stability going forward.

Bolster block trim pulled away from plaster finish

Center aisle post trim pulled away from plaster finish

**Picture 8: Post trim and bolster block pulling away from wall plaster at southeastern center aisle post of nave**

If the corbel block and the lower trim portion of that post section were to be temporarily removed, then the questions below could be investigated:

1. Confirm that the center aisle post in the wall beyond is *continuous* at the shed roof level
2. Find out how the corbel block is fastened to the center aisle post (in the wall). The existing fastening method should be increased/improved, as needed.
3. Confirm that the upper portion of the center aisle wall is leaning outward at the top, and not the post trim leaning inward at the shed roof level.

Such temporary trim removal would perhaps best conducted at the time when (or better yet: right before) the additional steel rod in that timber bent gets installed. At the time of the trim removal Annette Dey Engineering LLC should be called in to observe the exposed framing members and existing attachment methods on site.

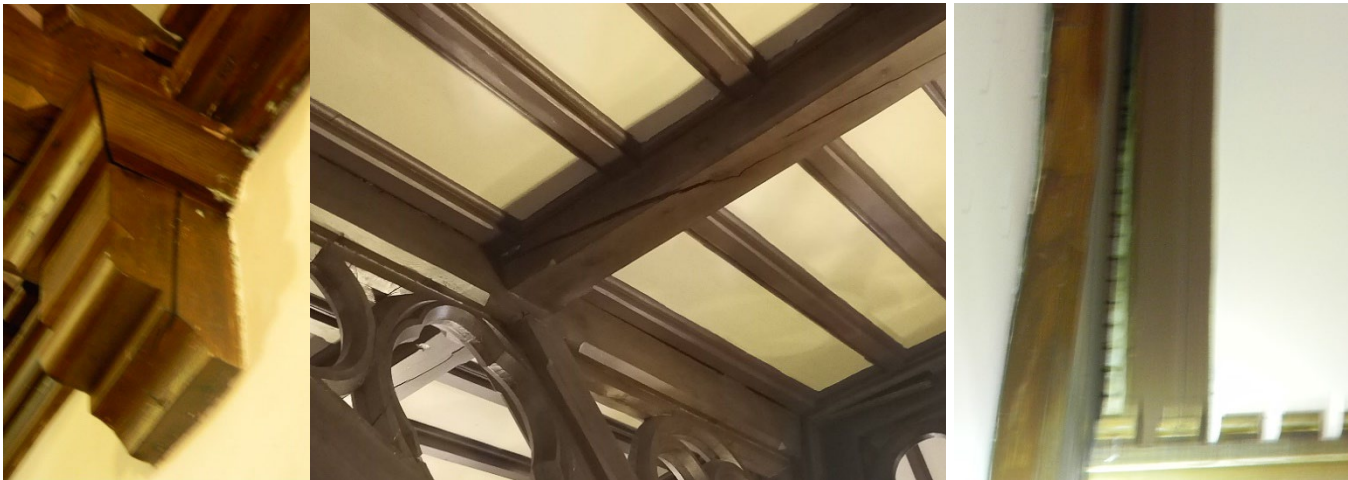
Cracking throughout the Sanctuary roof timber structural elements; Torsional cracking, such as that depicted in the image to the right, is of particular concern.

Ceiling structure has separated from wall to expose approximately 2" of lathe or roof strapping behind

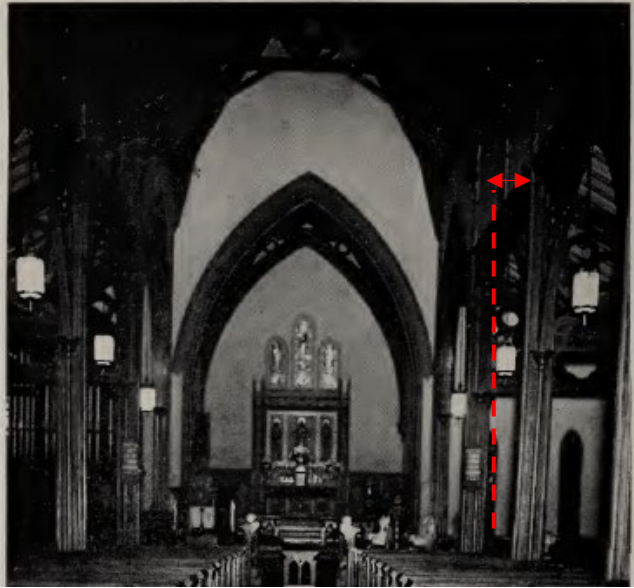
Sanctuary 1943, no tie rod, column leaning outwards

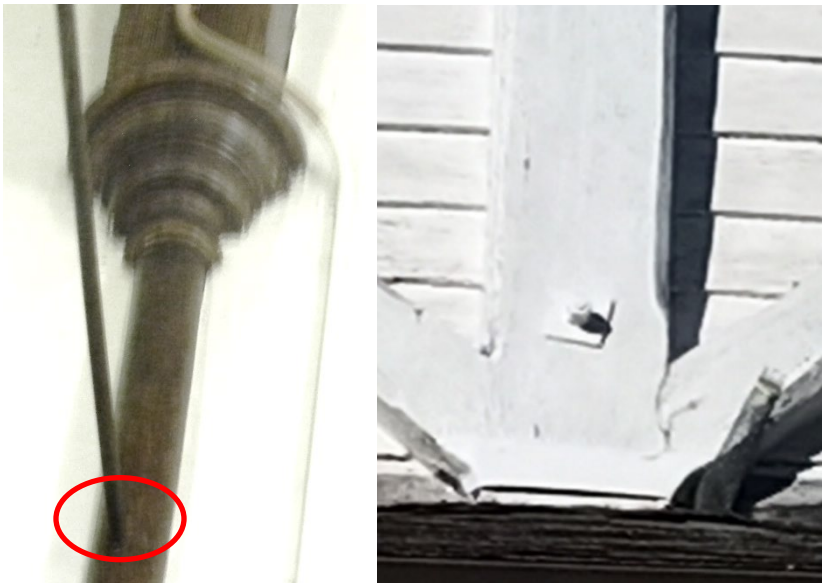
Above left is a view of the tie rod piercing the center of a timber column and right is a view of that same tie rod fastened on the exterior with a flat square plate and bolt.

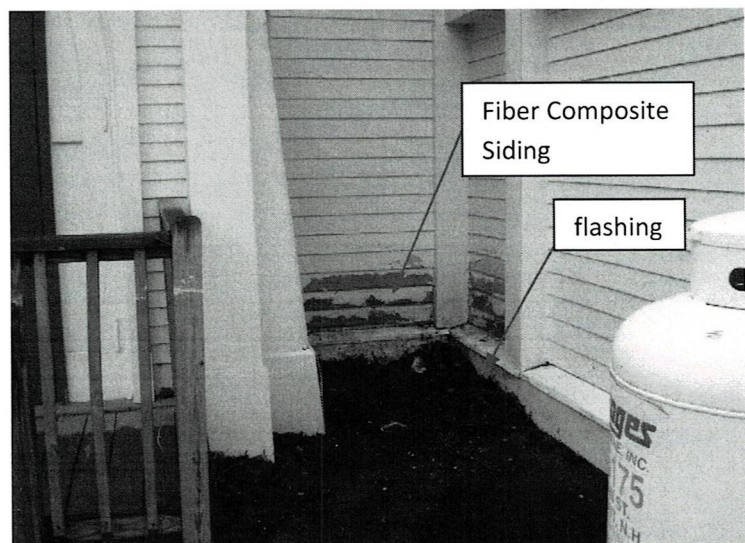
Figure 1: Flashing and siding maintenance have staved off deterioration in this wet area where paint won't hold but siding and sill are sound.

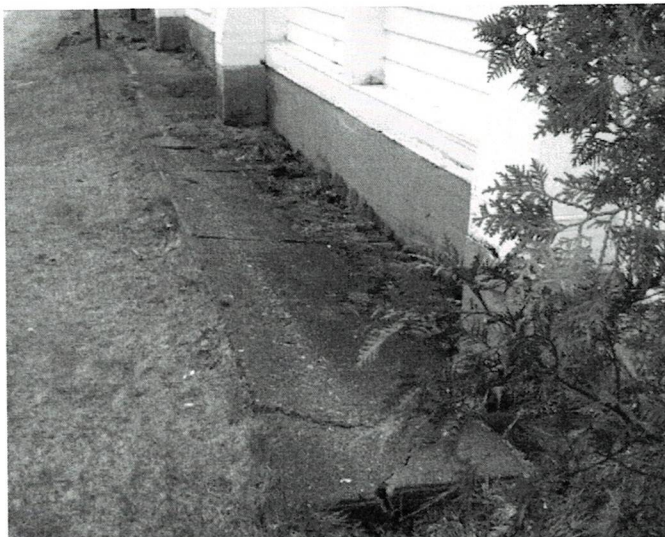
Figure 2 Northwest corner splash pad slopes toward building directing roof runoff to foundation.

While the building is wrapped with splash pads, along the north wall, a concrete splash pad slopes the wrong way. Here roof runoff is directed toward the building instead of away (Figure 2). Despite this condition, and a heavy coat of moss, the poured concrete wall below appeared sound and the sill free of rot. Subsequent observation from the interior revealed no sign of moisture, rot, or weak masonry.

3 shows the location of the westernmost splash pad on the northern wall. This splash pad slopes the wrong way in that it directs water toward the foundation. The splash pad should be either reset to slope away from the building, or demolished and replaced. The problem should be remediated before water and ice degrade the foundation wall.

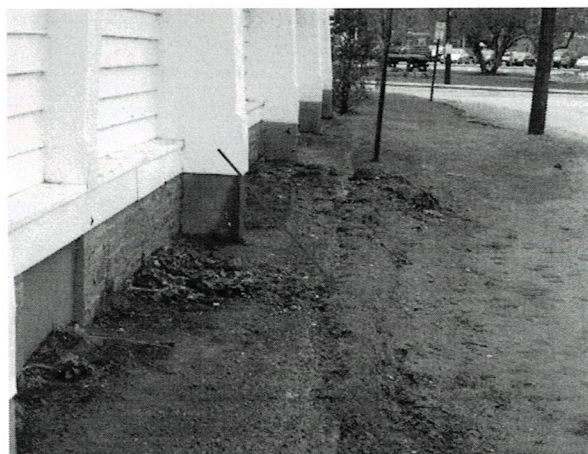
Along the same north wall, an accumulation of dirt and moss impede runoff and hold it close to the foundation (Figure 3). It is likely that this debris was left by winter snow plowing. Cleaning this residue would help keep the north wall dry.

Figure 3 Moss and debris impede runoff

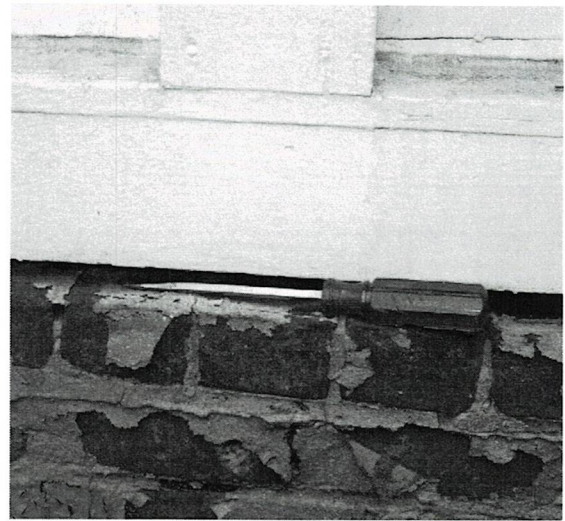
The entry alcove outside the sanctuary facing Broad Street revealed a similar loose masonry foundation. Here, the south wall is loose and can be moved on the order of  $\frac{1}{4}$ ". Here the bricks have settled leaving a gap of  $\frac{1}{4}$ " to  $\frac{1}{2}$ " between the sill and brick foundation (Figure 4). Subsequent observations from the crawlspace inside showed the interior brick to be firm and unyielding to pressure. The sill was sound. Though light was visible through the gap between the foundation and sill.

Figure 4 Loose brick on exterior and large separation between sill and foundation

1 and 4 show the approximate locations of the two areas where loose foundation brickwork was discovered. A masonry contractor should be employed to repair these walls to the limits of their degradation.

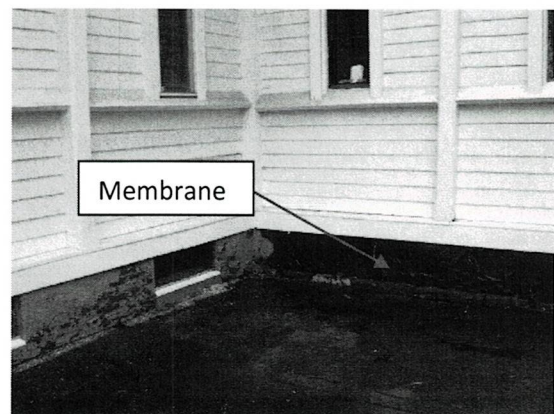
The third area of deteriorated foundation exists on the west wall, south of the sanctuary. The walls form an interior corner here and a roof valley funnels runoff into the corner. Though a paved splash pad exists here, the walls receive splash as water from the roof hits the paved apron. This area has received past attention. The exterior masonry could not be inspected because the foundation wall has been fitted with plywood and a modified bitumen membrane (Figure 5). The membrane was clearly installed as a means of protecting the masonry from the elements and further deterioration. It is unclear if the masonry was repaired prior to the installation of the protective membrane. Cladded as it was with plywood and membrane, the condition of the wall could not be observed or ascertained.

Figure 5 Brickwork has been fitted with a membrane under this roof valley.

Location 5 is the inside corner under the roof valley where a membrane has been placed to protect the brick foundation (Figure 5 previously). The area appears to have received past attention; it is important to confirm that the remedies were permanent repairs. Because of the membrane, it was not possible to observe the condition of the foundation. The inside crawl space showed evidence of past shoring but joist connections were obscured by debris. It is very possible that the repairs were permanent. Until this can be confirmed, it is equally likely that the repairs were temporary and more extensive work is called for.

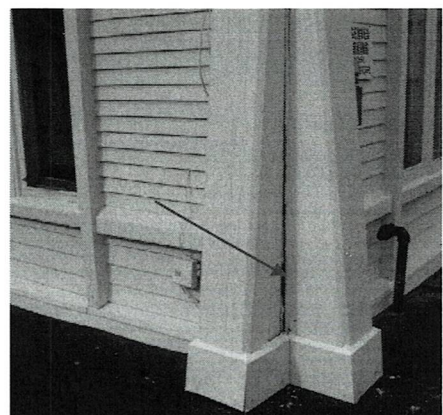
The exterior cladding and paint finish has been well maintained and reveals no rot. It is important to note however, that cladding on a column in the northwest corner of the structure has separated (Figures 6 & 7). The wood column inside is exposed to the elements and should be protected before rot ensues.

Figure 6 Separated cladding exposes timber column inside

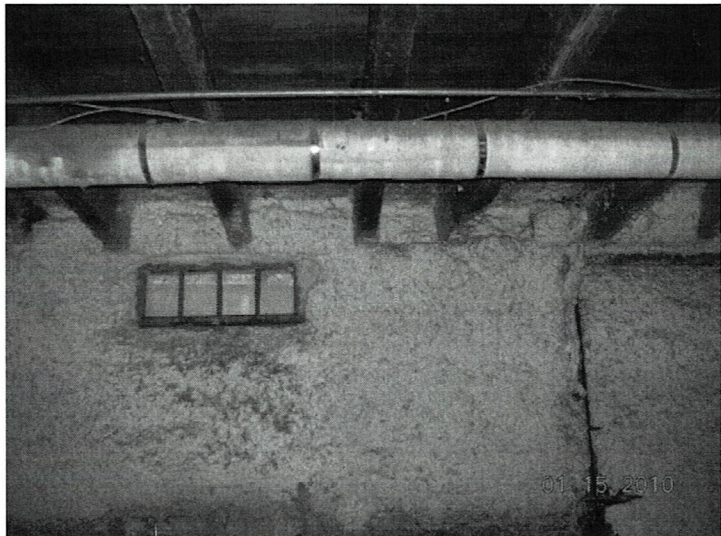
The foundation interior has been covered in spray cellulose insulation (Figure 8) for several feet below grade. In most areas the wood sill and masonry could not be visually inspected because of the cellulose insulation coating. GV performed a tactile investigation at regular intervals and found brick, stone and poured concrete walls to resist penetration and pressure. The foundation interior revealed no loose brick, soft, or crumbling masonry.

Figure 8 Insulation covers sill and wall but sill, joist and masonry resisted penetration wherever checked.

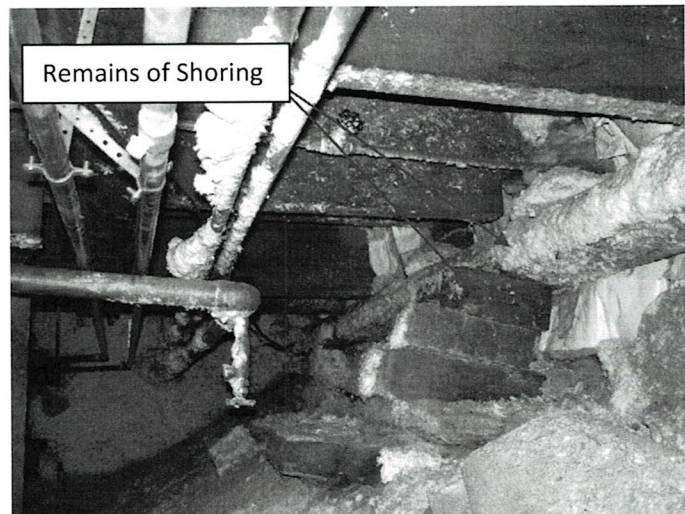
The third area of concern, the brick on the west wall, covered in membrane could not be closely observed due to obstacles and low head room in the crawl space. At one time the joists perpendicular the wall had been shored and the shoring remains below the joists. Some joists have been notched for their previous bearing but no cracks are evident. While the existing connection or bearing of these joists was not visible and could not be observed, the joists were rigid, as was the floor above. The floor above revealed little bounce or deflection.

Figure 9 Plumbing, rubble, and insulation prevented closer observation of this north crawl space wall. Once shored these joist connections could not be observed

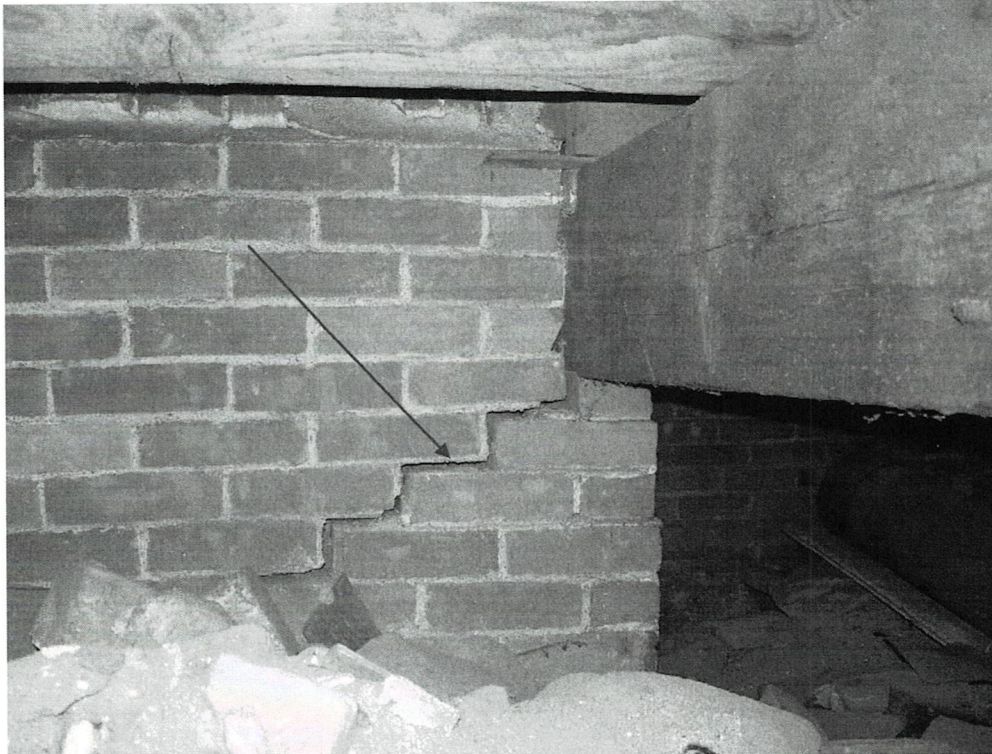
Two beams in the crawl space appear to have problematic supports. The more serious of the two bears in a pocket on the outside corner of a brick wall. The wall has deflected and a significant crack appears at a diagonal to the load (Figure 10). Since the bearing masonry wall has failed, the beam should be temporarily supported until a permanent bearing can be fitted.

Figure 10 Bearing wall in failure.

Figure 10 showed a failed masonry wall under a beam. The Beam in question should be temporarily supported until a permanent bearing can be designed and put into service.

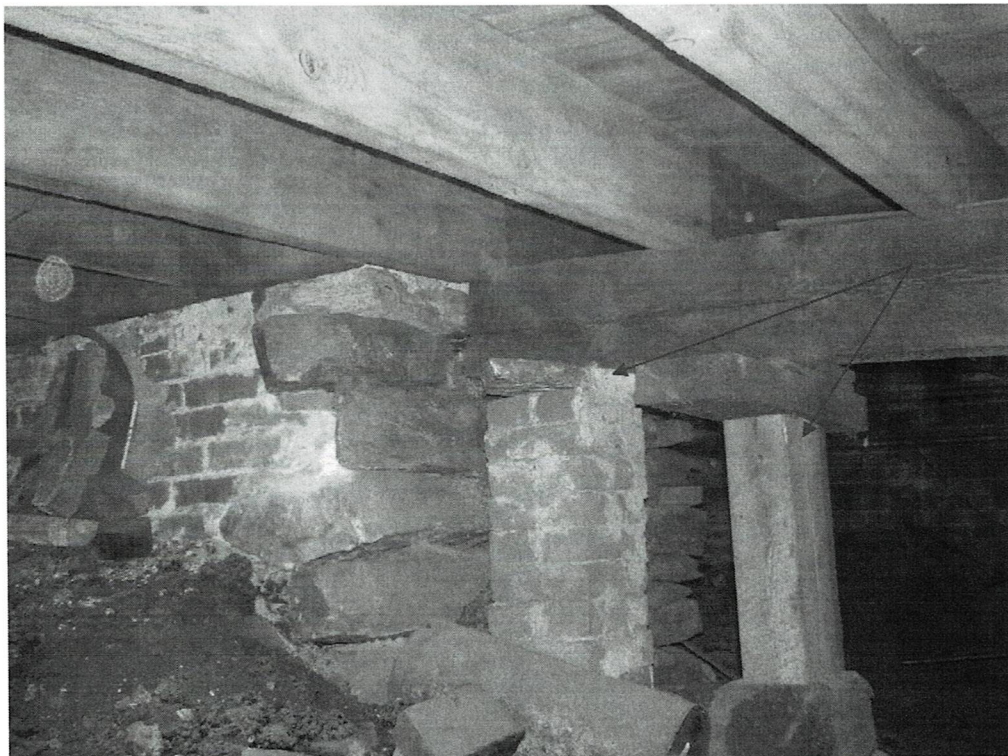
The second troublesome bearing in the crawl space has been shored (Figure 11). The beam rests on a brick column with stone cap. A timber support has been fitted inside the brick column. The timber support is not vertical and blocking has been fitted atop the timber column to make up the several inches between the top of column and the bottom of the beam. The beam/column connection likely offers no lateral stability or positive means of fixity.

Figure 11 Bearing & Support lack fixity and lateral stability.

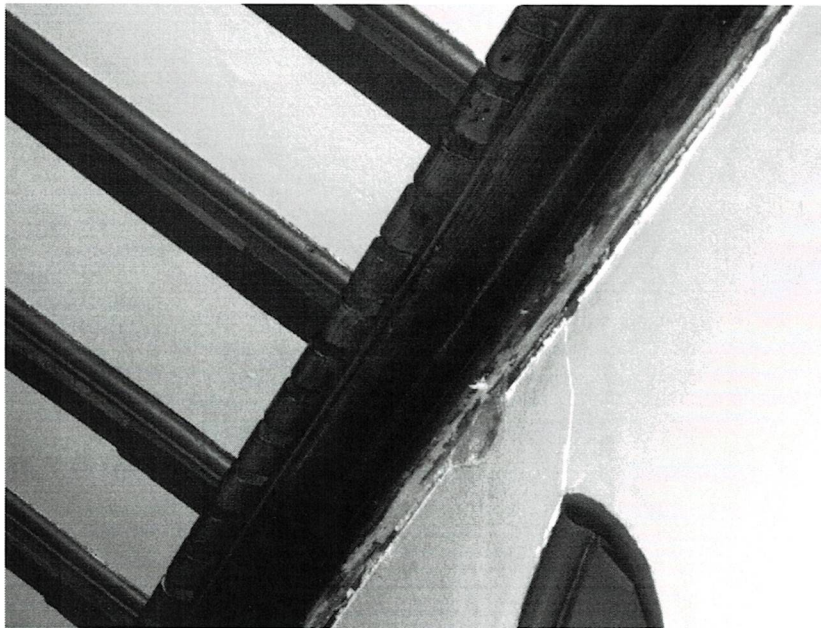
Observations from both inside and outside the sanctuary show no obvious failure or profound outward movement of the walls. Evidence suggests however there may be small movement in the outer wall. Specifically, in the north wall, the plaster has separated from the cornice molding (Figure 13). Also, lack of stain (color variation) at the inner connection of one bottom truss chord suggests movement on the order of 1/2"–3/4" (Figure 14). The plaster has also cracked over the stained glass windows; but this is not surprising, given the size and shape of the windows. If the plaster is going to crack, it will tend to crack over the window where the wall section is smallest.

Figure 13 Loose Plaster at cornice, owing to the window size and shape, the plaster crack is no surprise.

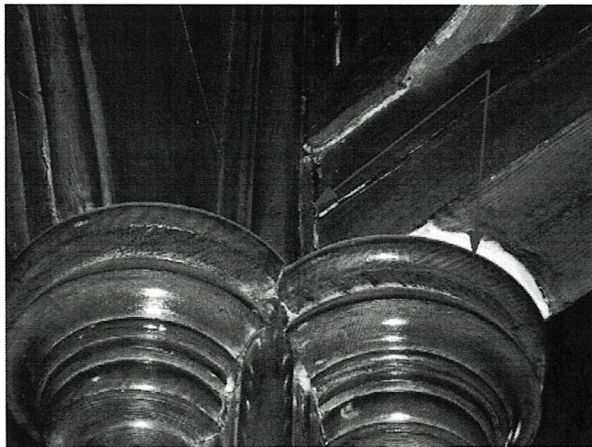
Over three visits, dating from January to April, the sanctuary roof revealed no obvious or profound failure. There is evidence however of some movement (up to  $\frac{3}{4}'' \pm$ ) of the bottom truss chord from the inner column. This was particularly visible on the north side. The bottom chord joints at the outer wall are tight. Without more exhaustive study little more can be known.

Figure 14 Lack of Stain suggests Bottom Chord has moved  $\frac{1}{2}''$  to  $\frac{3}{4}''$ . It is not clear how the chord connects to the Column.
