## **Structural Report**

**Trinity Episcopal Church  
120 Broad Street  
Claremont, NH**

22 October 2025

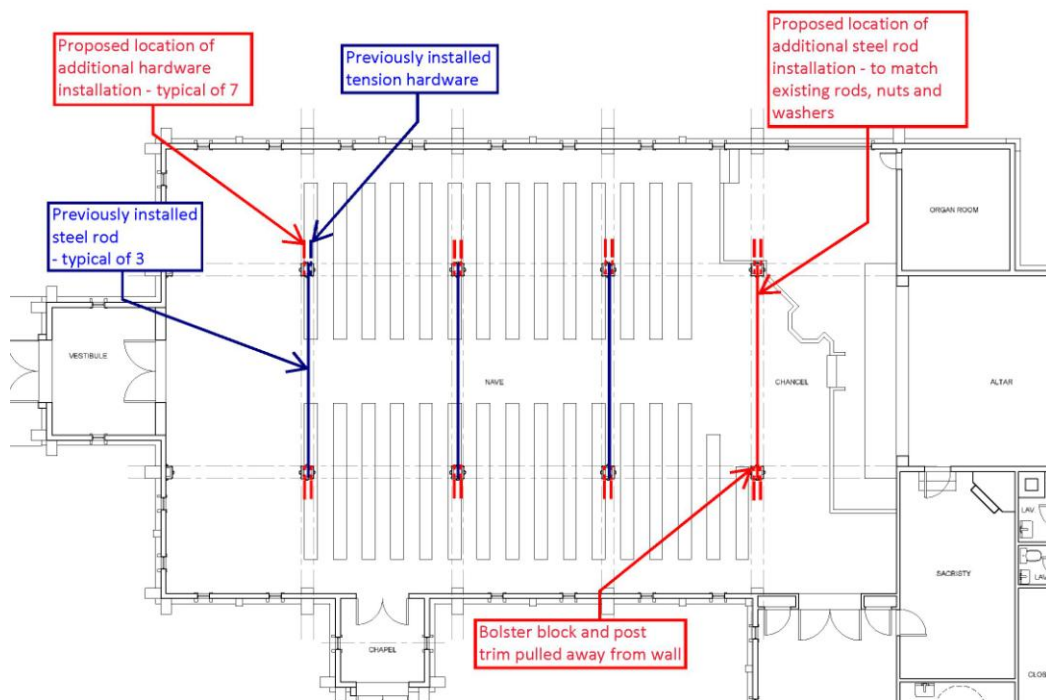
The proposed reinforcement detail for the bottom chord to center aisle post connections is shown on the next page. Below is a floor plan of the nave with the existing and proposed new hardware layout. As featured in the layout plan, ***it is recommended to install a steel rod in the eastern-most timber bent of the nave as well.***

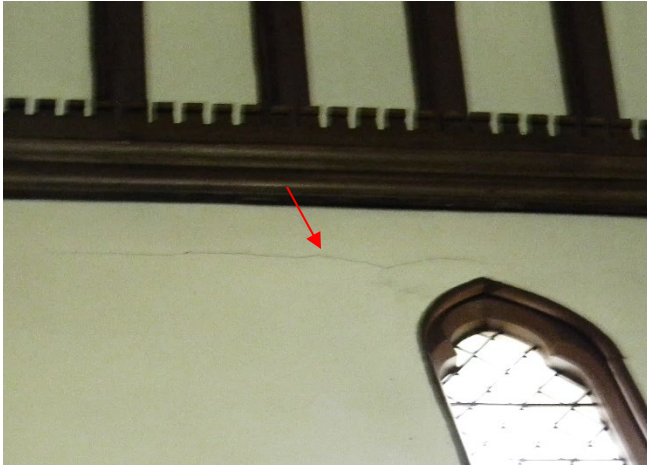
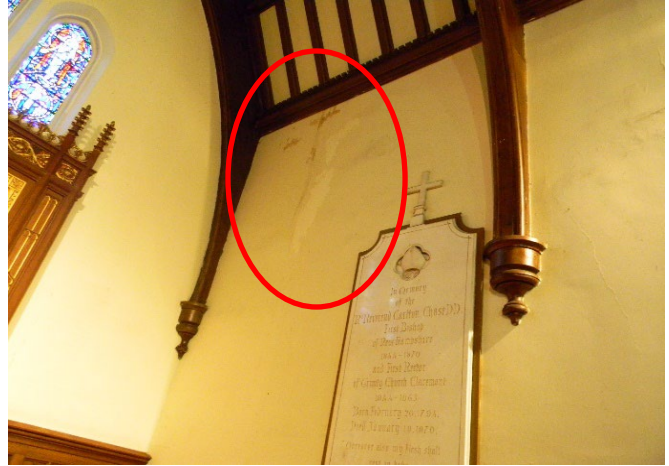
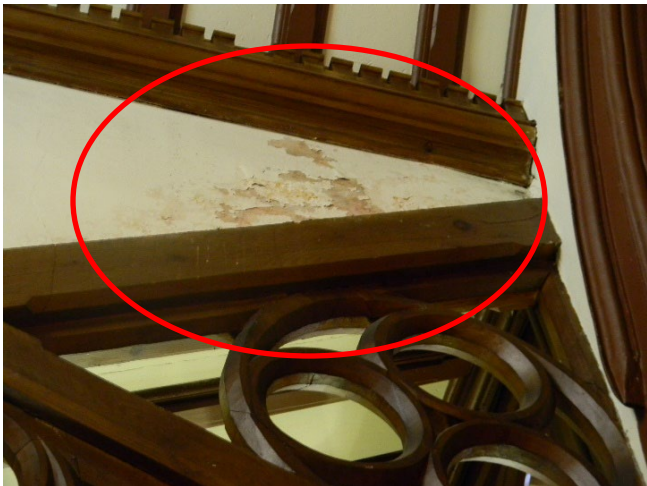
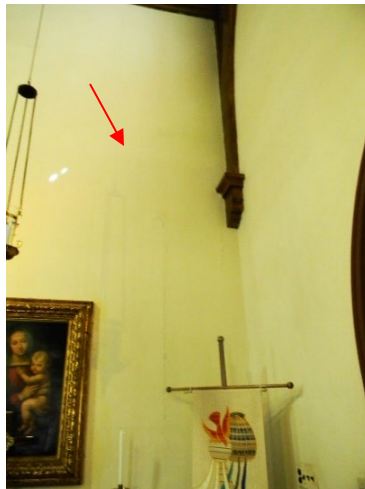
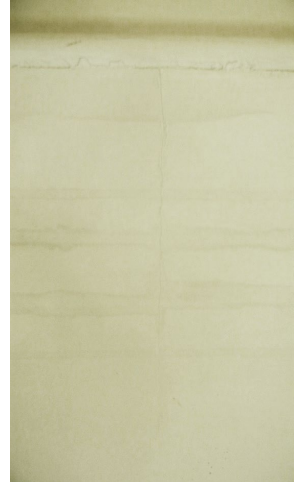
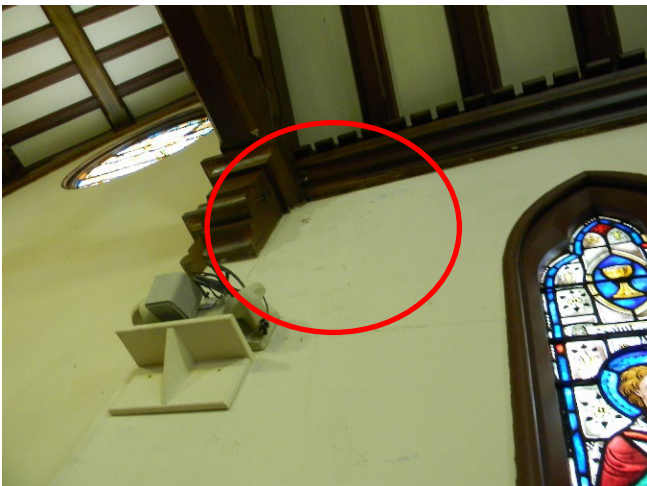
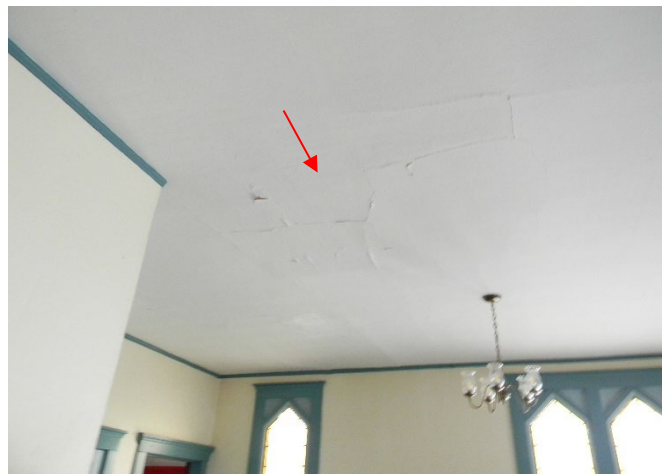
Cracked, stained, bubbled plaster was observed in selective areas throughout the Sanctuary and Parish Hall. Some areas of damage appeared to have resulted from leaks that are no longer active. Most areas of damage correspond to complicated roof junctures / areas of improper roof drainage on the exterior. Hairline plaster cracks at upper level windows in the Sanctuary are likely due to roof movement when stressed by wind or load.

Damaged interior finishes should be replaced. This is included as a Low Priority item, as repairing the conditions that cause the damage are High priority. Paint sampling & analysis may be undertaken during Sanctuary repairs, in order to determine earlier paint color schemes.

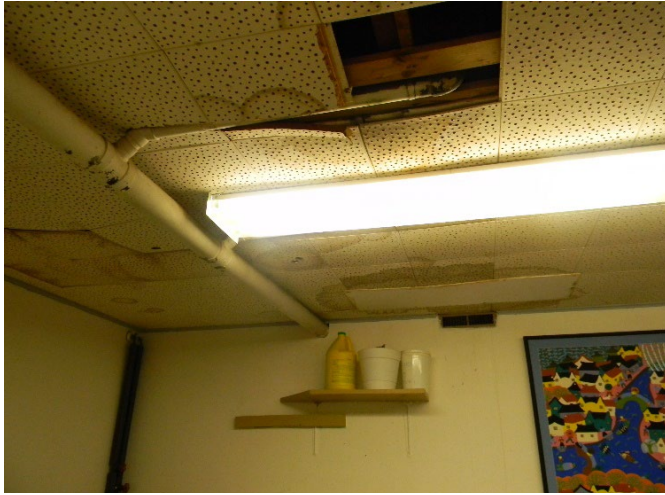
Water-stained ceiling tiles throughout the Basement are reported to have resulted from an interior plumbing issue that has since been repaired.

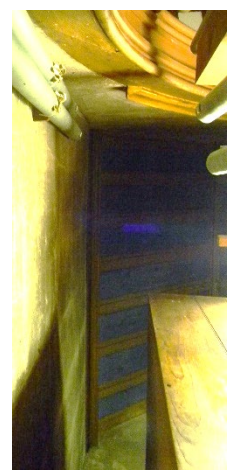
Ceiling of the Organ room is painted blue, perhaps indicative of an earlier color scheme

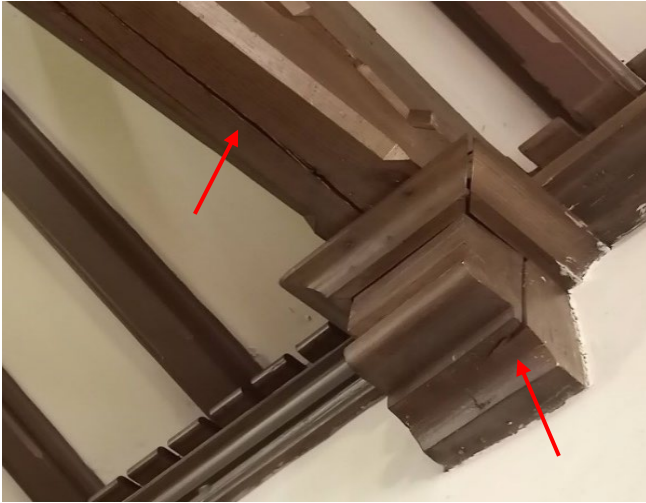
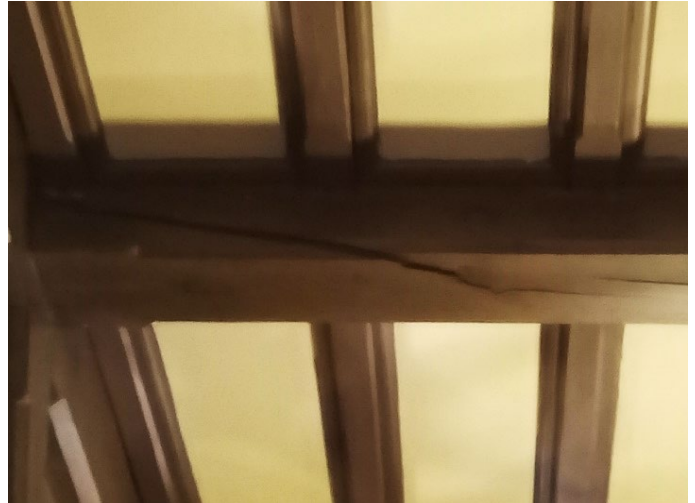
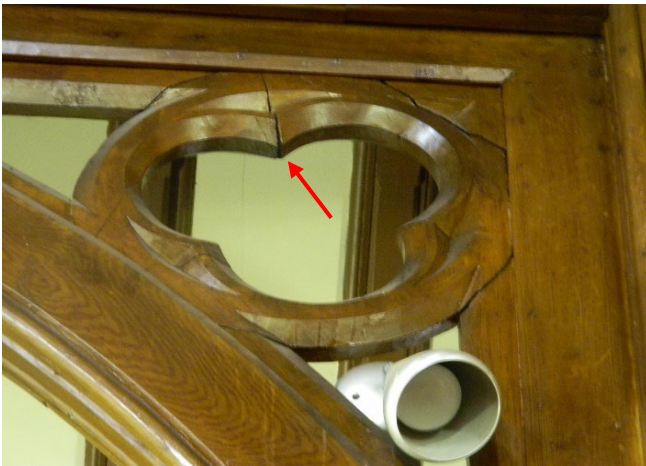
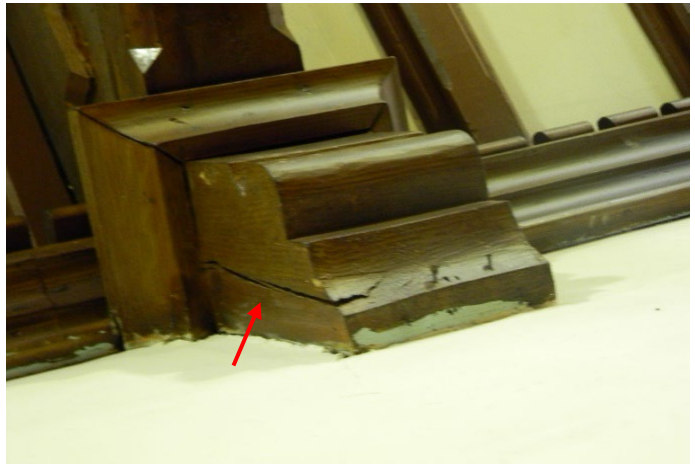
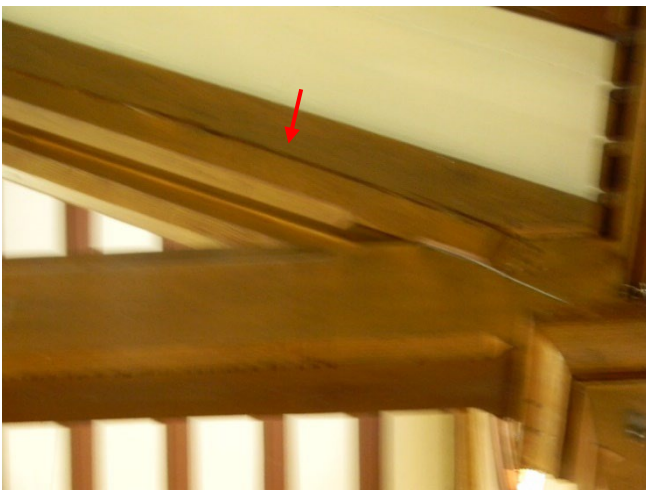
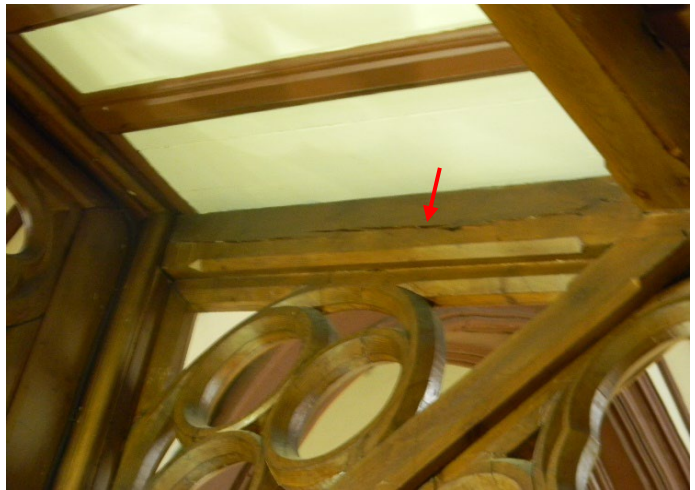
Cracking throughout the Sanctuary roof timber structural elements was observed throughout.

It is recommended that a thorough structural analysis be undertaken by an engineer experienced with timber framing or a timber framing specialist. Some minimal destructive probes will likely be required, one at each type of connection. If roof replacement is undertaken, this would be a good opportunity to use scaffolding access and opened roof areas to perform such an analysis. In the meantime, a system of monitoring should be put in place, with each truss given a number and its cracks photographed and measured every year at minimum.

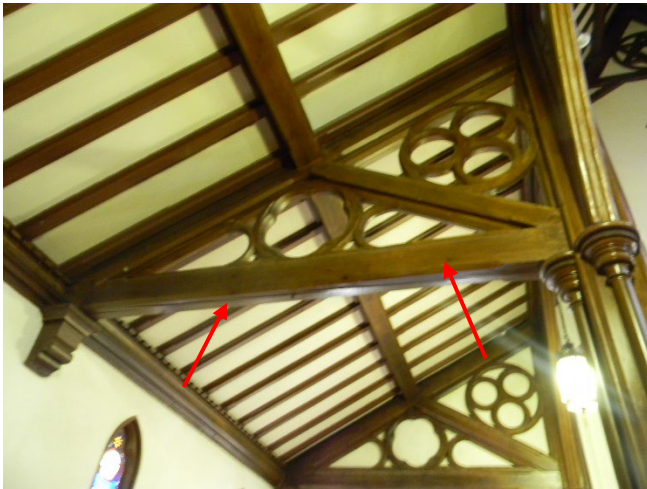
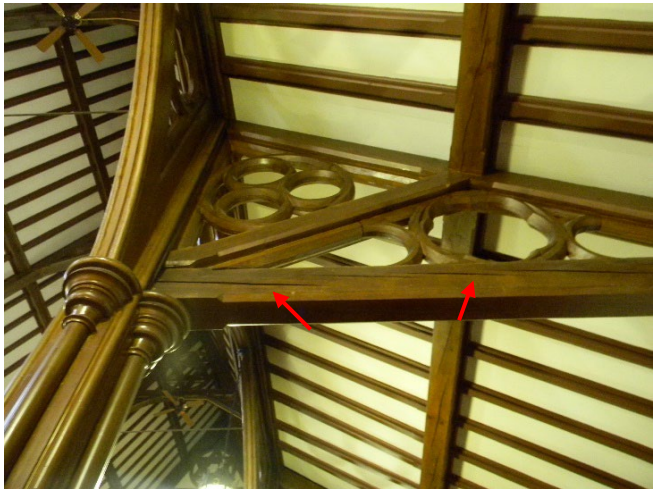
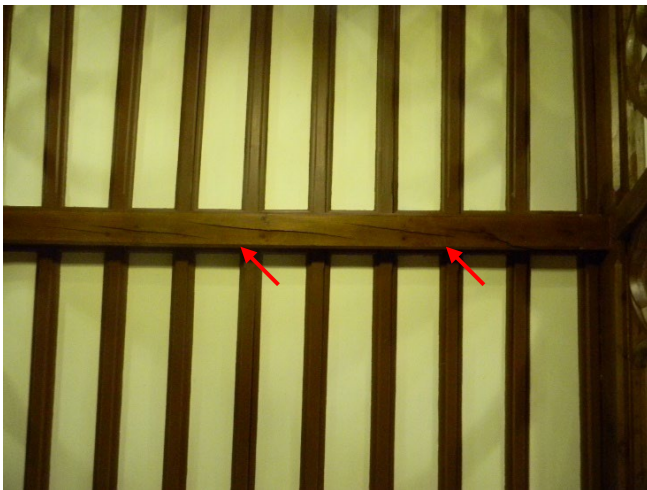
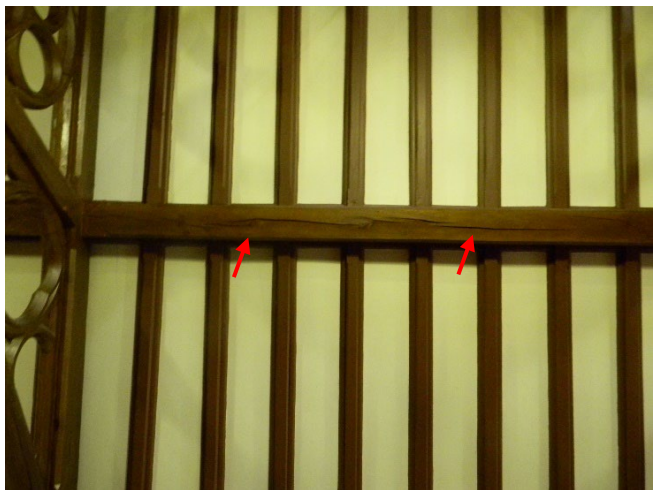
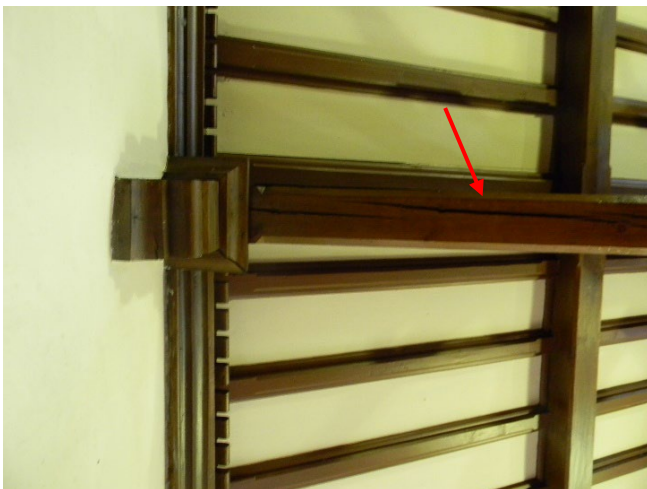
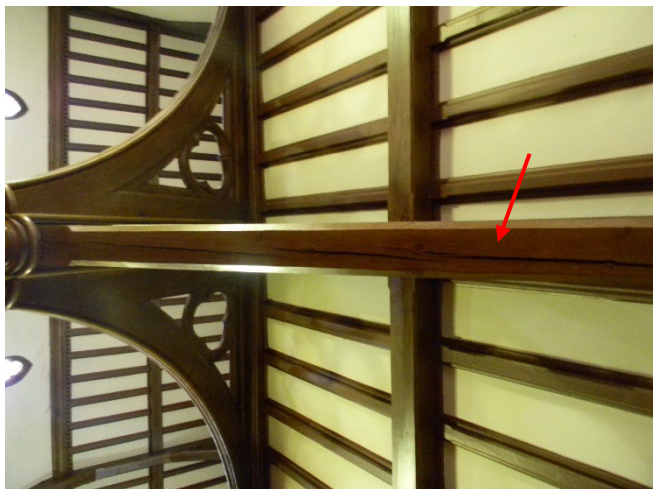
Cracking throughout the Sanctuary roof timber structural elements was observed throughout.

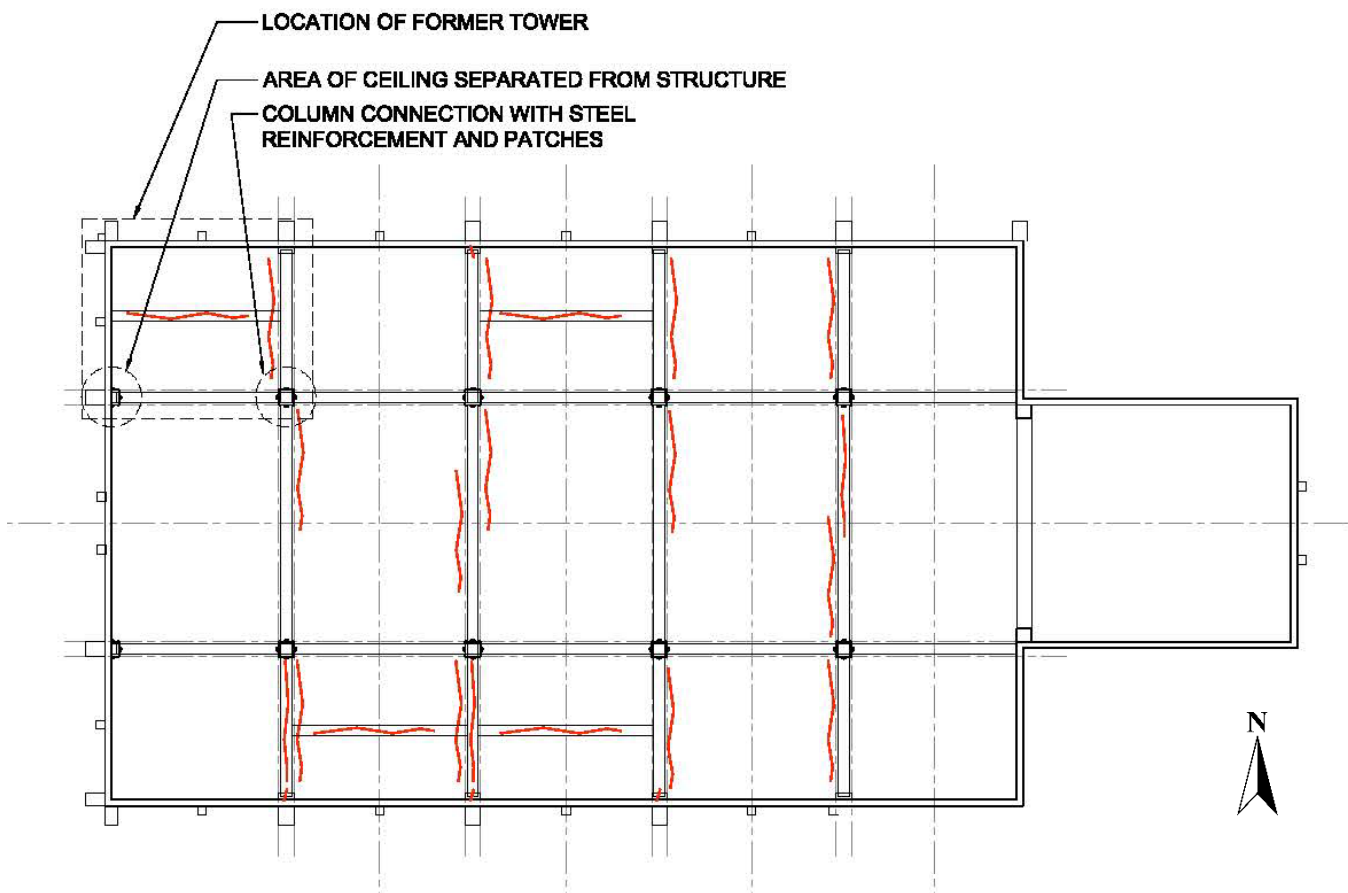
Diagrammatic Structural Plan documenting cracked timber structural elements observed in 2023

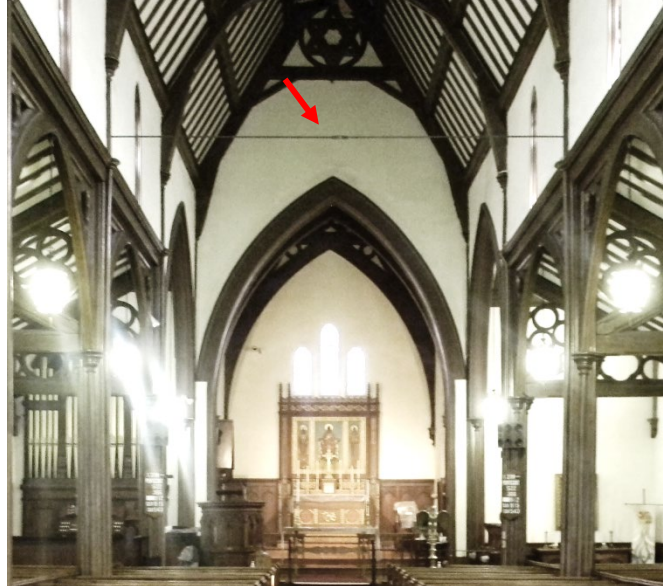
Sanctuary 2023

Below photos suggest that the steel tension rods in the Sanctuary were installed in the 1963 repair campaign, when the corner that was previously occupied by the tower was reconstructed for the second time. The building likely incurred structural damage throughout in the 1938 hurricane, but particularly in the exposed, vulnerable Sanctuary.

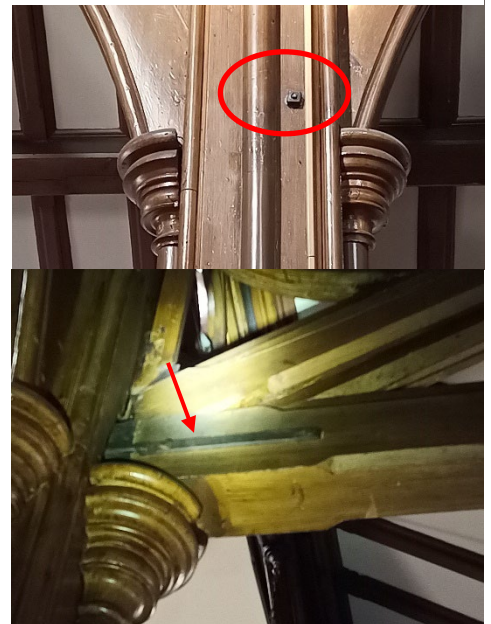
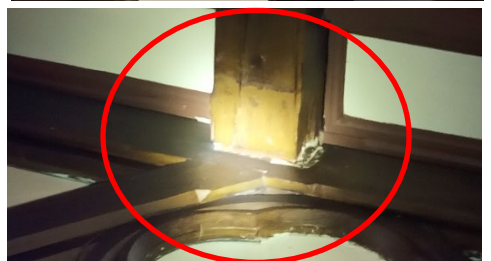
Upper right and middle shows different views of the same column, with steel reinforcing installed. This column is located in the corner of the original tower, which was reconstructed in 1963. Below right, evidence of Dutchmen patch repair, also located in the corner occupied by the tower.

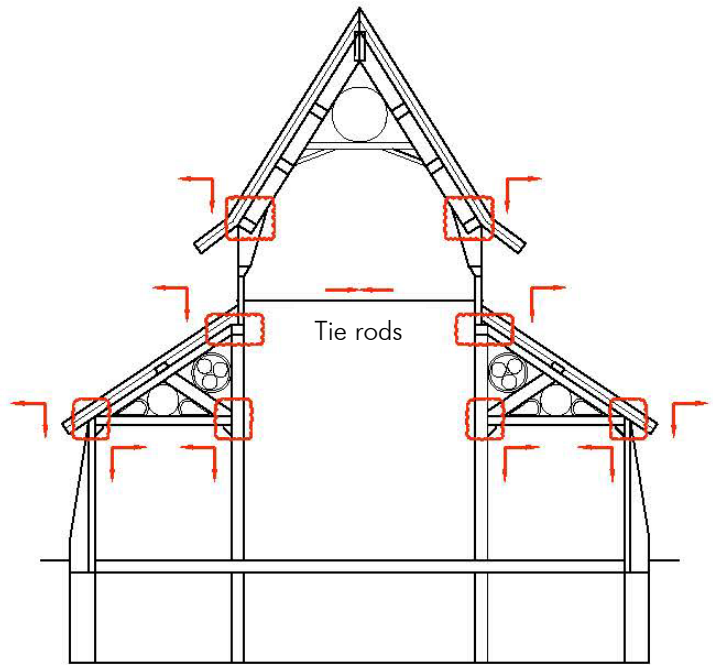
It is evident from the type of cracking observed throughout the Sanctuary roof framing that the structure is, or was at some time, experiencing stress beyond its capacity. This could result from the structure being under-designed for the loads and/or a major stressful event like the collapse of the tower in the 1938 hurricane. It is possible that the tie-rods installed, likely in 1963, were successful at counter-acting the excessive outward stresses. There is no way to know if the cracks observed in 2023 existed in 1963 and were the impetus for the installation of the tie-rods, or if any have worsened or appeared since. Also, because many of the structural members are concealed by cladding on both the exterior and interior, and connections are concealed by ornament on the interior, it is not possible to easily determine the framing member sizes and types of connections in order to run a simple analysis. On a positive note, the cracking is isolated to the framing members, only minor cracks in the plaster and minimally out-of-plane plaster walls were observed.

Diagram of stresses acting on roof structure and joints to be examined further.

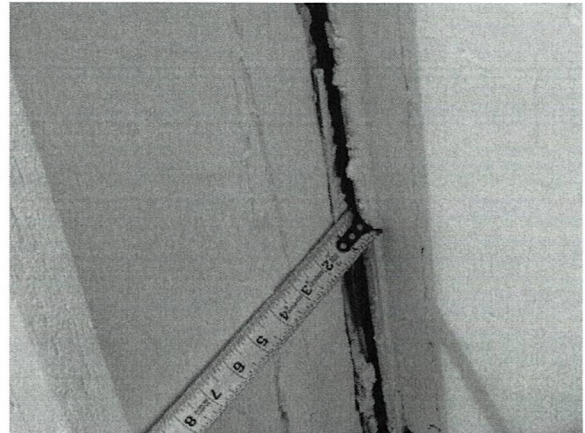
Figure 7

The exterior cladding and paint finish has been well maintained and reveals no rot. It is important to note however, that cladding on a column in the northwest corner of the structure has separated (Figures 6 & 7). The wood column inside is exposed to the elements and should be protected before rot ensues.

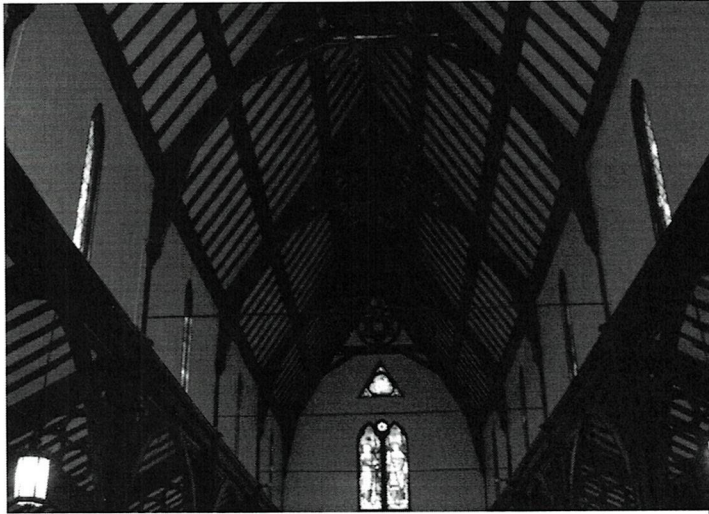
The Sanctuary Roof was observed during all three visits. The Center roof is vaulted and flanked by two lower roofs on each side (Figure 12). The outward horizontal thrust of the vaulted center roof is resisted by metal ties with turnbuckles. The metal ties connect to columns, well below the bottom of the upper roof. The position of these ties, well down the column, puts the columns in bending. That is to say, as the tension in the tie is transferred to the column, a moment develops (tension in the tie becomes moment in the column). The lower roofs flanking the vaulted center are supported by a timber truss. Here, tension in the bottom chord of the truss

Figure 12 Vaulted Center Roof with flanking Lower Roofs.  
Horizontal Ties connecting to columns.

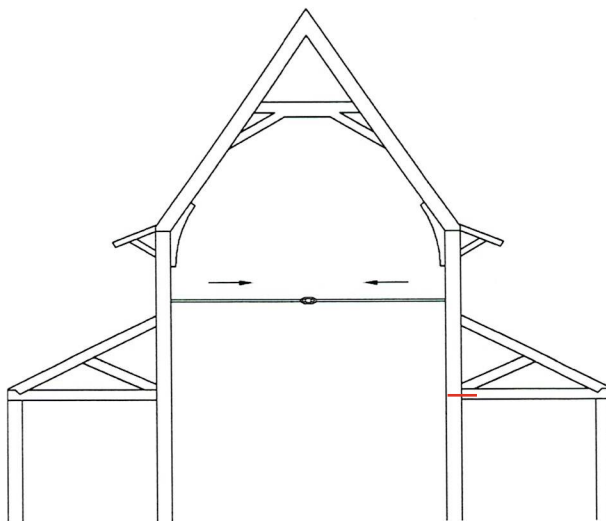
Sketch 1 Tension in Tie transfers to Column.  
(Not to Scale)

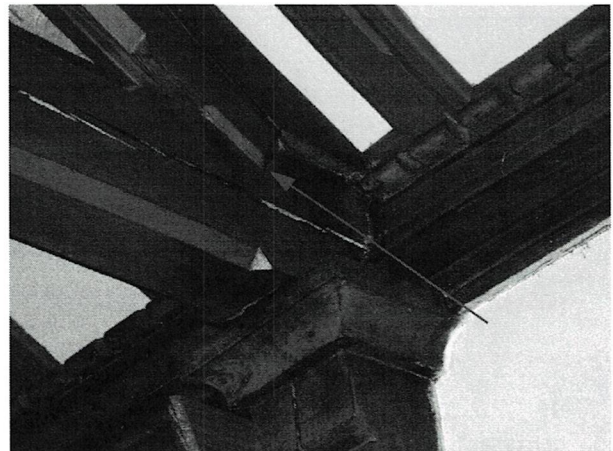
By inspection, the bottom chord timbers appear to be adequately sized to carry the tension to resist outward thrust *provided the connections on both ends adequately transfer the thrust into tension* in the bottom chord. The connection at the outer wall is a visible timber connection designed to do just that. The top chord is notched into the bottom chord (Figure 15). Because the inner end connection of the bottom chord is concealed, it is not clear how this bottom chord is connected to the column however. Because this connection cannot be inspected, it is impossible to know if the bottom chord is developing enough tension to resist the roof thrust.

Figure 15 Exterior Timber connection of Bottom Chord is designed to transfers thrust into Tension in Bottom Chord.
